Structural stability analysis of structure by destructive and NDT: a case study of Ladies hostel, Vallabh Vidyanagar, AnandGuj

It is important to analyze the old structures for structural integration to understand the type and extent of damage the structure has sustained and what type of retrofitting is further required. The case study involves a 55 years old building that has suffered extensive weathering damage. Rigorous analysis for functionality and durability of the structure was done using non-destructive testing methods (NDT) and core cutting. Two NDT methods employed were ultrasonic pulse velocity (UPV) and rebound hammer (RH) along with core cutting at a critical location. A damage contour map was drawn for a better understanding of the extent and intensity of damage sustained by the structure and appropriate retrofitting and repairs were advised.

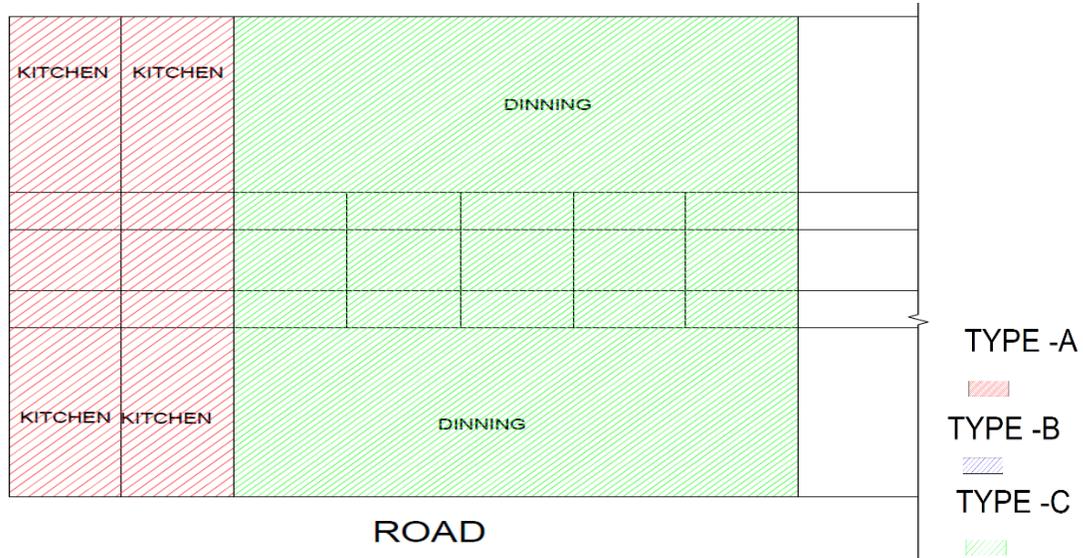
Fig. 6 Ground floor damage contour

Type A	All room balcony. Lobby slabs near the washrooms and bathrooms. The interior part of the kitchen. A slab of washrooms of stair cabin on the top floor.
Type B	All rooms at the top floor level. Stair slab and landing slab. Walls corresponding to restrooms and bathrooms.
Type C	All remaining rooms, dining and assembly area

- Mostly all the sub-locations of the ground floor are relatively undamaged but the balconies of all the room (wall and slab of balconies), slabs of the lobby, and terrace slab are damaged considerably and must be retrofitted or removed as early as possible.

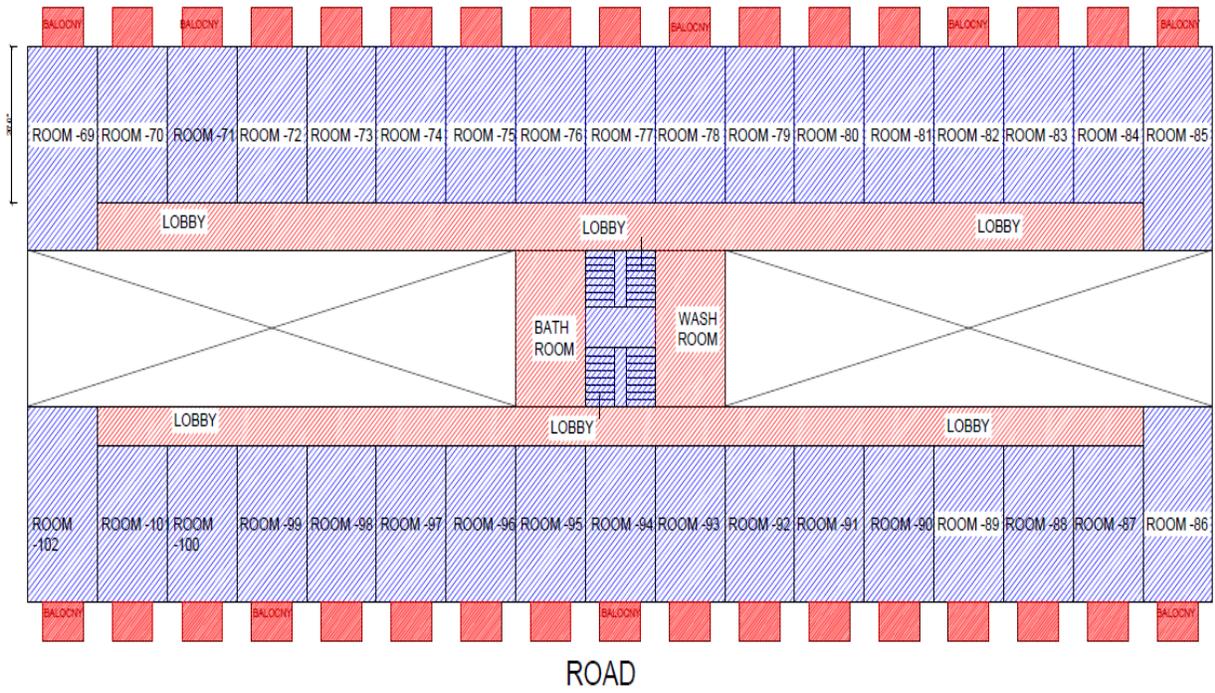
Fig. 8 3rd floor damage contour

River pebbles are used in the entire structure except for the terrace. Proper cover to the reinforcements was not provided and because of that, substantial corrosion in reinforcements is observed due to weathering. Reinforcements in the slab of the lobby are exposed especially on the 1st and 2nd floors and there is water leakage on the slab of the 3rd floor which is due to the installation of solar panel on the terrace above room no 86 to 102.
