Signaling Relay Contact Failure Analysis with 3D Profilometry, SEM and EDS

Susmita Sau¹, Sajjan Kumar², Sankar Narayan Patra³, Subhash Chandra Panja⁴

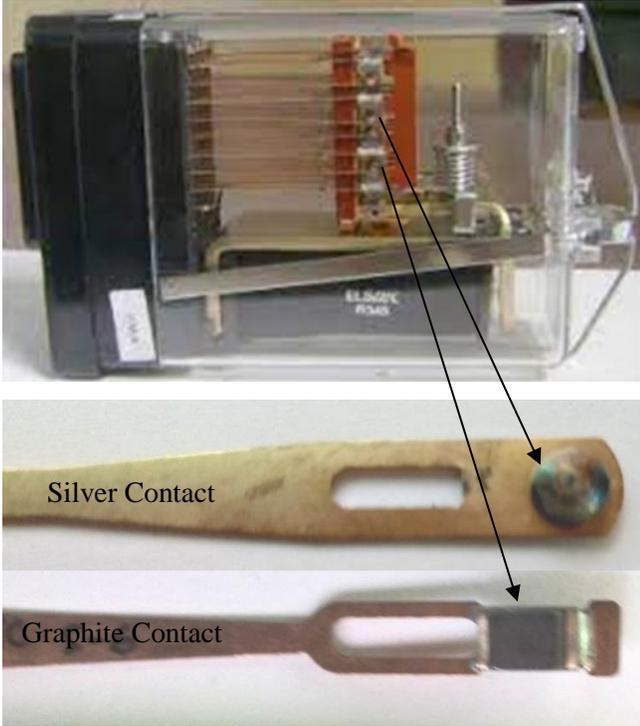
Fig. 1 QN1 series signalling relay and relay contacts dismantled SIG contact and silver contact

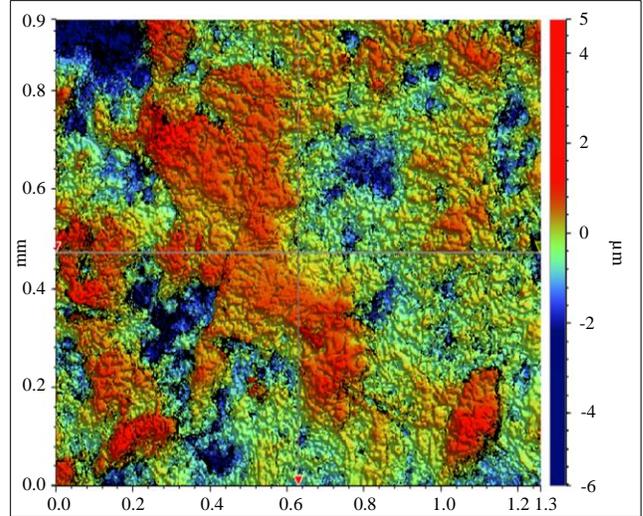
Fig. 2 Surface roughness of SIG contact before knocking (2D-sample 1)

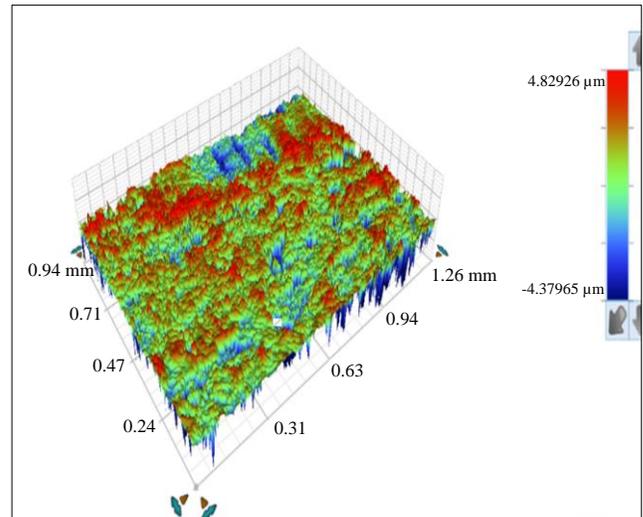
Fig. 3 Surface roughness of SIG contact before knocking (3D-sample 1)

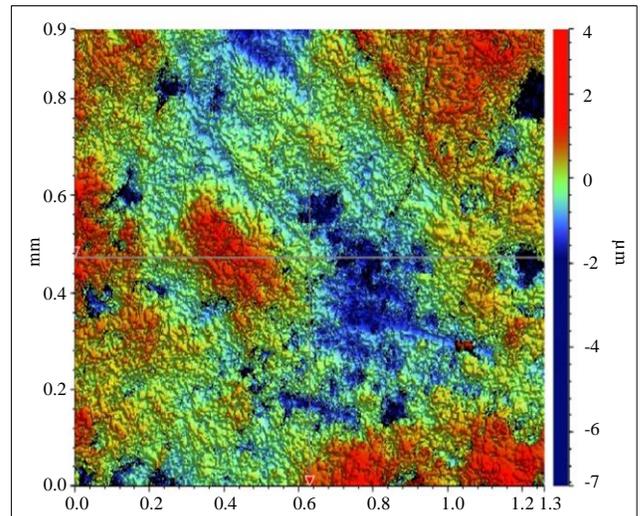
Fig. 4 Surface roughness of SIG contact before knocking (2D-sample 2)

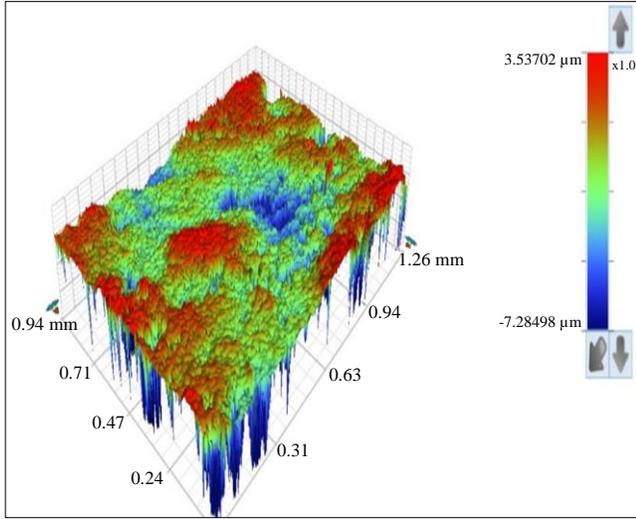
Fig. 5 Surface roughness of SIG contact before knocking (3D-sample 2)

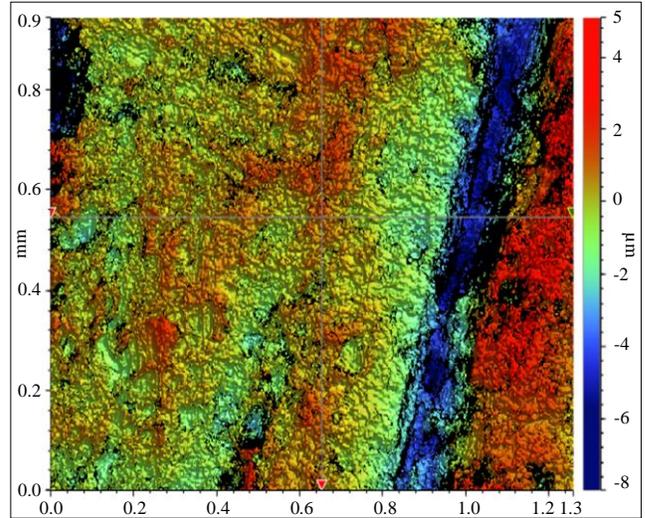
Figure 6 shows the 2D surface roughness of failed SIG contact, and Figure 7 shows 3D surface roughness after 10,000 knockings of SIG contact. Figure 8 shows the 2D surface roughness of SIG contact under post-failure conditions, and Figure 9 shows the 3D surface roughness of SIG contact under post-failure conditions after 15,000 knocking.

Fig. 8 Surface roughness of SIG contact post-failure (2D-sample 4)

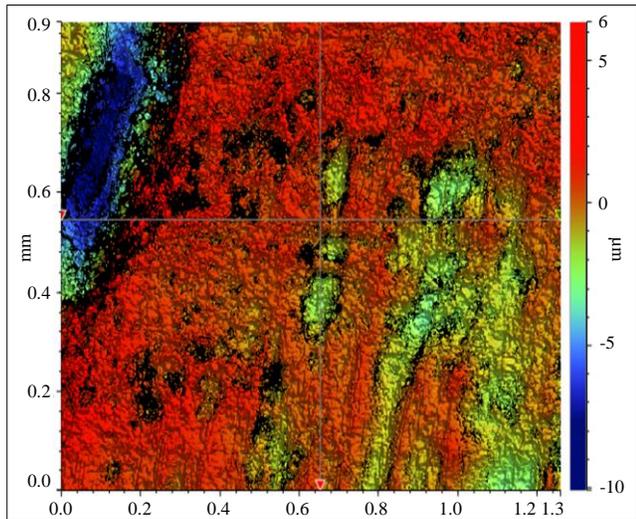
Fig. 6 Surface roughness of SIG contact post-failure (2D-sample 3)

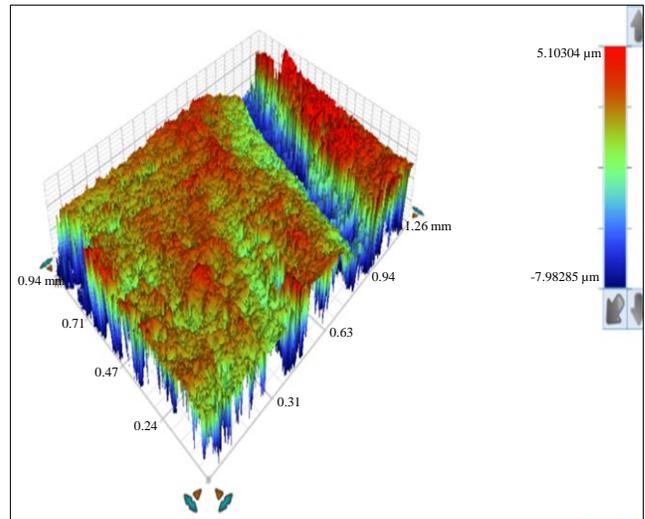
Fig. 9 Surface roughness of SIG contact post-failure (3D-sample 4)

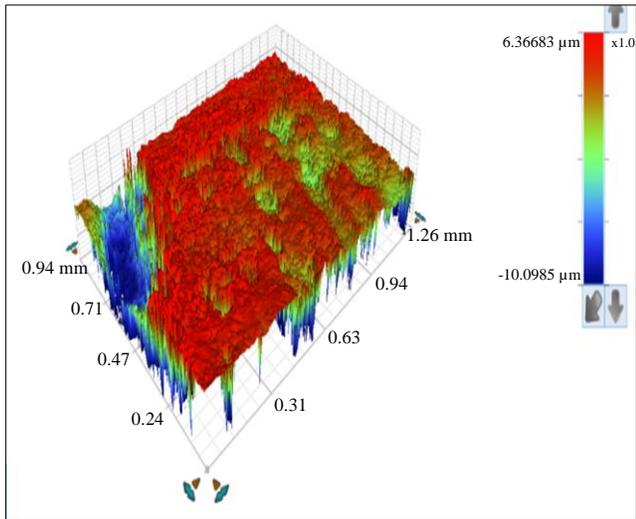
Fig. 7 Surface roughness of SIG contact post-failure (3D-sample 3)

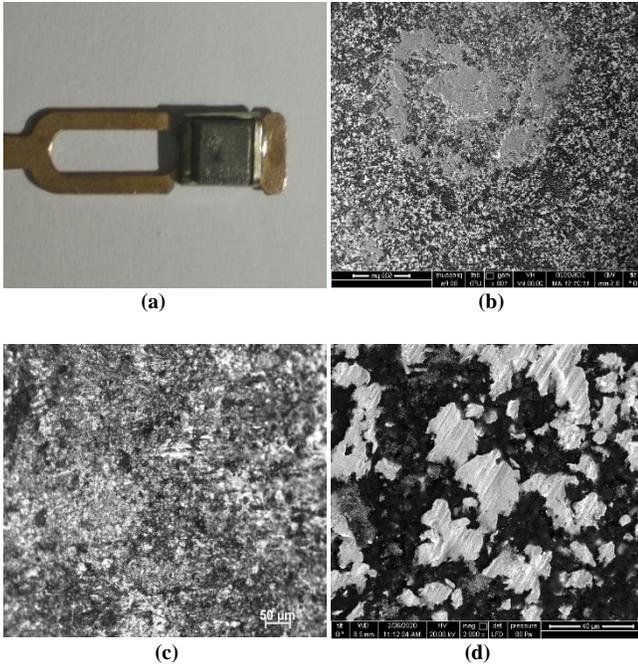
Figures 10(b), 10(c), and 10(d) show SIG contact surface under FESEM investigation of 500μm, 50μm, and 40μm magnification before failure. Similarly, Figures 11(a), 11(b), and 11(c) show SIG contact surface under FESEM investigation of 50μm, 40μm, 2μm, and 500nm magnification after failure.

Fig. 10 FESEM image of the surface of SIG contact before failure (a) Dismantled SIG movable contact, (b) 500µm, (c) 50µm, and (d) 40µm.

In Figure 10, the SIG contact of the relay before failure shows a nearly smooth surface. Movable SIG contact material is made of graphite, which is softer than fixed silver contact material. Load, stress, and environmental stress conditions affected the contact surface of the movable SIG contact. Figure 11 shows the rough surface of the contact due to

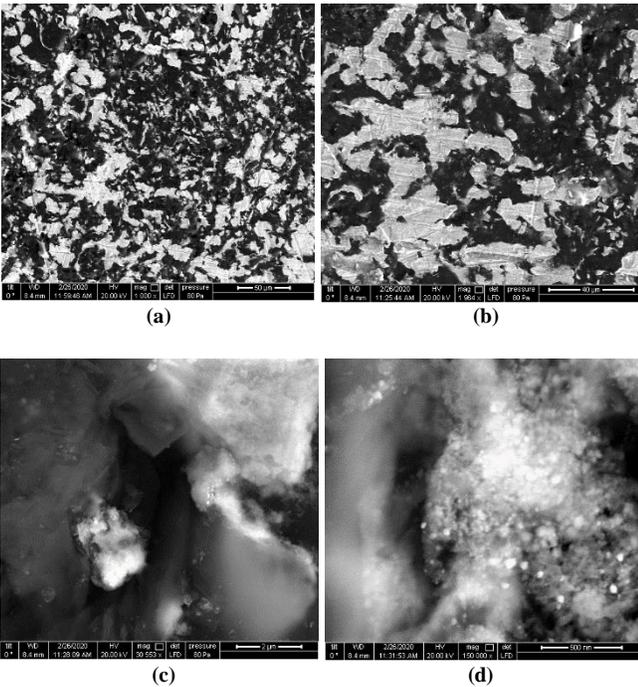
Fig 11. FESEM image of the surface of SIG contact after failure (a) SIG contact surface at 50 µm, (b) 40 µm, (c) 2 µm, and (d) 500 nm.

erosion, arching, and molten signs present on the surface of the SIG contact. The surface of the contact became porous, and molten metallic particles were present on the micrograph. A thin film has formed due to dirt, debris, impurities on the surface or due to oxidation, sulphation, or corrosion. Figures 11(c), and 11(d) show molten lumps and adhesion on the surface.

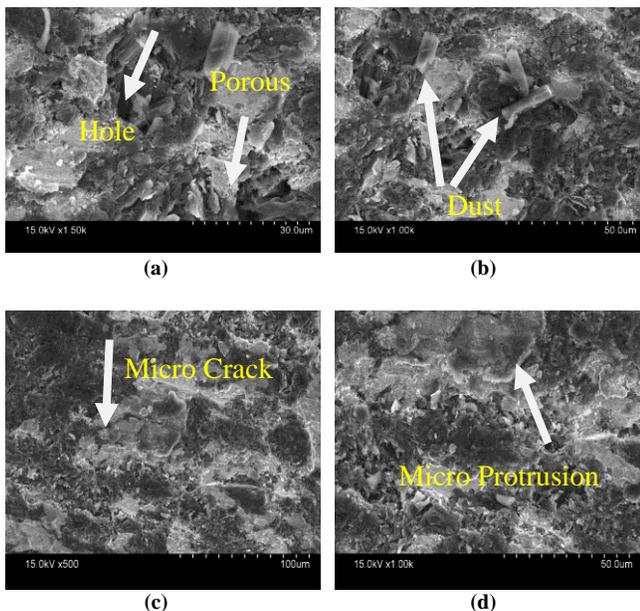
The SEM is applied to examine the surface morphology of different samples of the SIG contact. Figure 12, Figure 13, Figure 14, and Figure 15. (Sample A, Sample B, Sample C, Sample D) show various types of surface failure. Figure 12, SIG (Sample A) clearly shows contact adhesion occurred, and the surface became porous; holes and dust particles are visible in Figures 12(a), and 12(b). In Figures 12(c), and 12(d) magnified 100 µm and 50 µm images show micro-cracks and micro protrusion due to contact pressure, surface irregularities and material properties. Contact surfaces exhibit massive heat, which causes micro protrusion and micro cracks. various mechanical damage erosion, cracks, and holes are visible on the surface of the contact.

Fig. 12 SEM image of the surface of SIG contact (Sample A) after failure (a) SIG contact surface at 30 μm, (b) 50 μm (c) 100 μm, and (d) 50 μm.

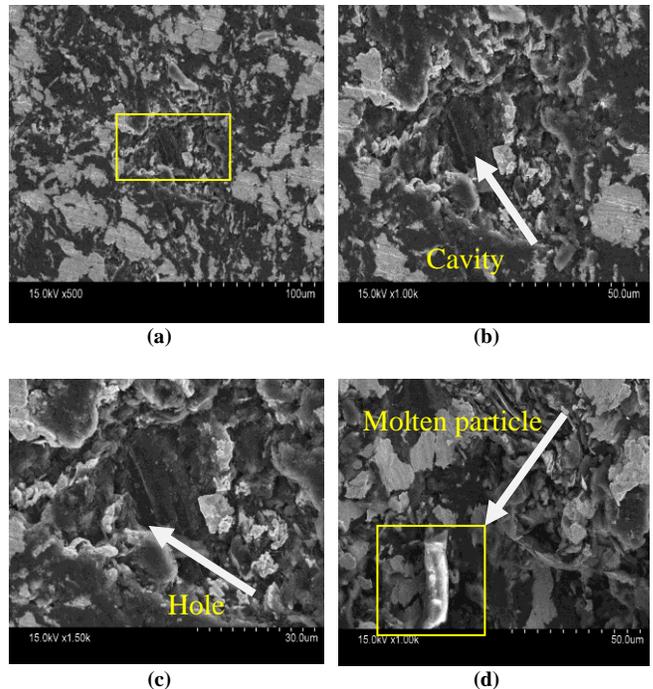
Irregularities present in the surface of the SIG contact surface (Sample B) are shown in Figure 13. Cavities and molten particles are observed on the SIG contact surface of movable contact in Figures 13(a), 13(b), and 13(c). Electrical arcing generates excessive heat. The heat vaporizes the contact material and erodes, leaving behind cavities and molten particles on the surface of the contact. The contact material gradually erodes over time due to electrical current and mechanical stress, causing holes to develop. Dust and contaminant particles caused localized corrosion or erosion, which contributed to hole formation. In Figure 13(d), a molten particle is shown. In Figures 14(a), and 14(b) molten particle particles appeared on the SIG contact (Sample C) surface due to intense electrical arcing during switching operations.

Fig. 13 SEM image of the surface of SIG contact (Sample B) after failure (a) SIG contact surface at 30 μm, (b) 50 μm (c) 100 μm, and (d) 50 μm.

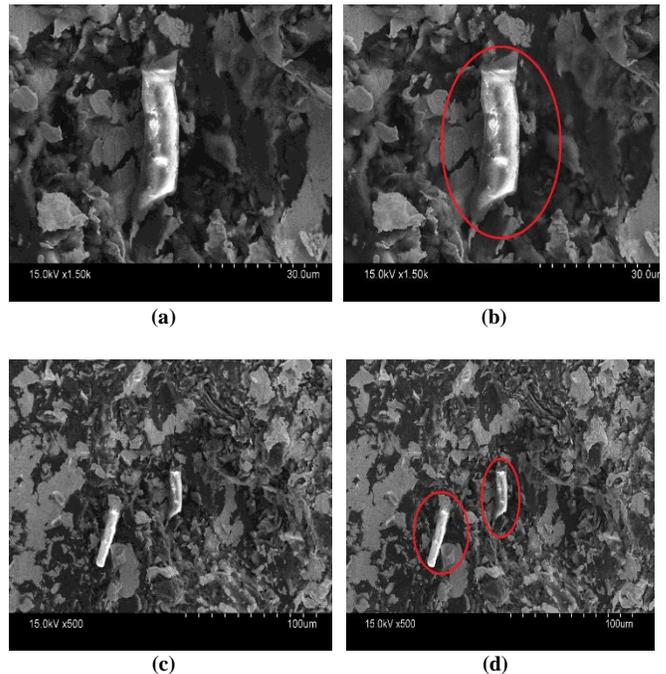
In Figure 14(d), magnified dust, dirt, and other contaminants were found on the surface of the relay contact, which caused localized areas of increased resistance. A thin film has formed on the surface of SIG contact. In Figure 15 (Sample D), a porous scalable surface is shown. Cavity, molten particles clearly visible in Figures 15(a), 15(b), 15(c), and 15(d) shows dust particles.

Fig. 14 SEM image of the surface of SIG contact (Sample C) after failure (a) SIG contact surface at 30 μm, (b) 50 μm (c) 100 μm, and (d) 50 μm.

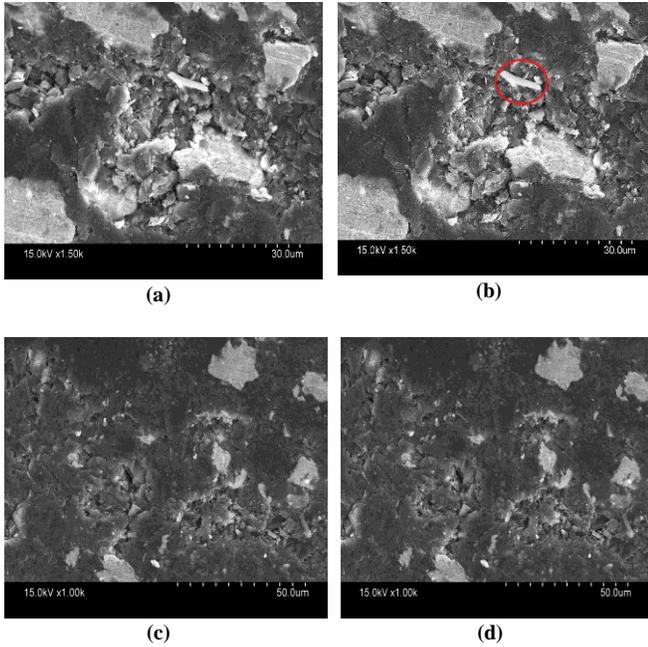
Fig. 15 SEM image of the surface of SIG contact(Sample D) after failure (a) SIG contact surface at 30 μm, (b) 30 μm (c) 30 μm, and (d) 50 μm.

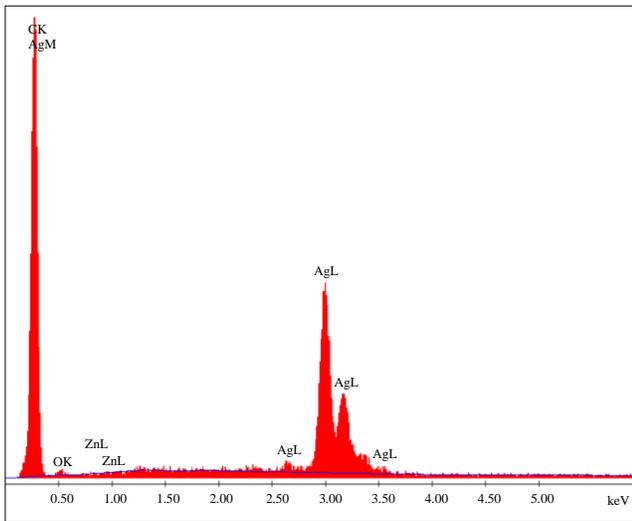
contact are depicted in Table 2, and Table 3. From the results, SIG contact before failure had no free carbon granules present on the surface. Oxygen content was less in fresh SIG. The silver content was present in fresh SIG. Fixed silver contact before failure content silver, carbon, oxygen, and silver.

Fig. 16 EDS image of the surface of SIG contact before failure

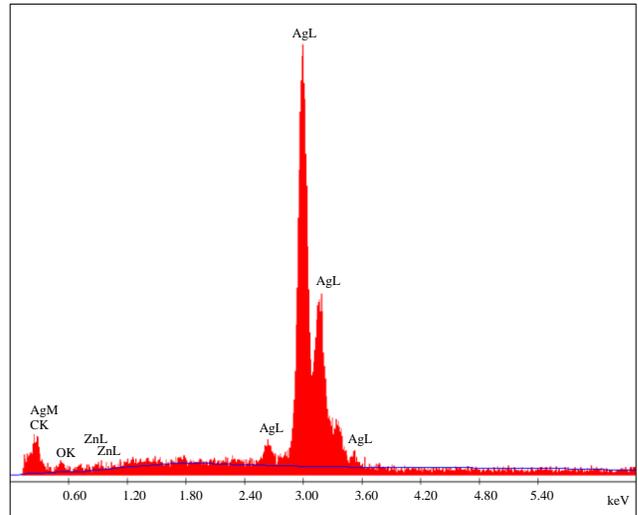
Fig. 17 EDS image of the surface of silver fixed contact before failure

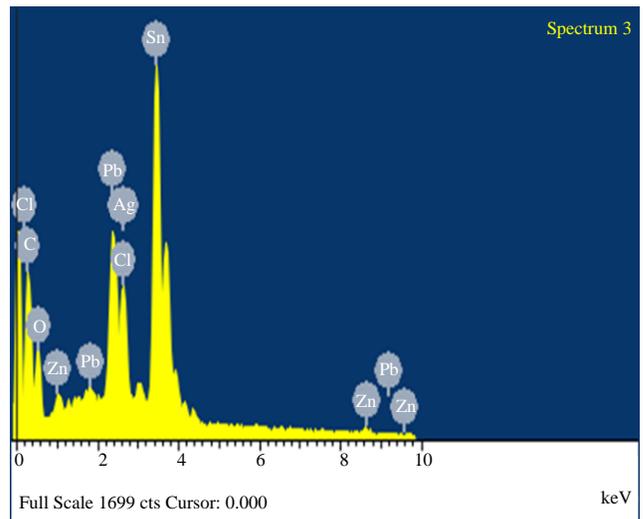
Similarly, EDS delivers energy spectrum for SIG spectrum and silver contact after failure. In Figure 18, and Figure 19 the energy spectrum of SIG contact and silver contact are shown. It is observed from Table 4 that oxidation, sulphation, and carbide formation happen, which causes high contact resistance on the SIG contact after failure. Besides other chemical impurities viz silicon dioxide, potassium oxide, zinc oxide, and calcium carbonate are present on the surface of the SIG contact.

Fig. 18 EDAX image of the surface of SIG contact after failure

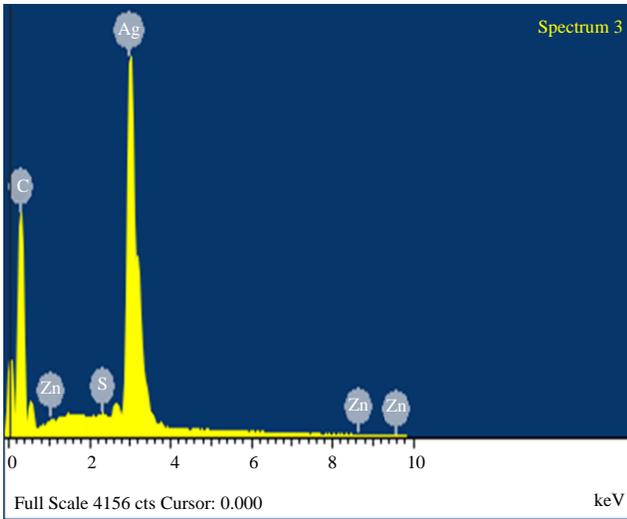
Hence, Table 5 shows that after the failure of silver contact, silver content decreased from 85.01% to 77.15% in the failed sample. This suggested that the silver element had eroded after failure. A thin film develops on the SIG contact surface due to repeated contact cycling in relay operations. This film, in turn, triggers electrical arcing between the silver and SIG contacts, resulting in higher contact surface temperature.

Fig. 19 EDAX image of the surface of silver contact after failure
