Some Observations on Premature Damage to Automotive Wheel Hub Bearings

S D Rasika Perera

Department of Mechanical Engineering, The Open University of Sri Lanka, Nawala, Nugegoda, Sri Lanka.

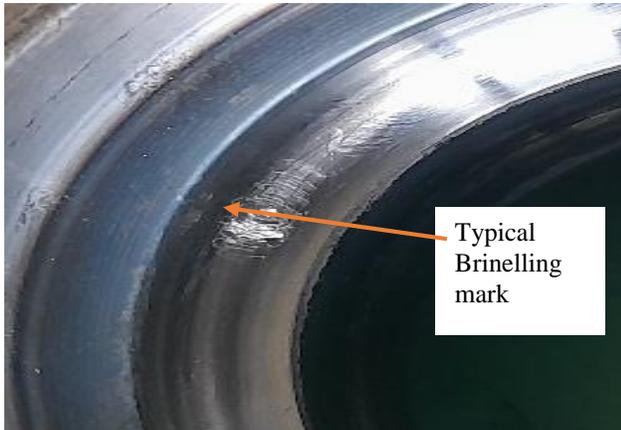
Fig. 3 Damage observed on the 32,000 km bearing assembly

The damage observed on the 32,000 km bearing assembly is shown in Figure 3.

A noticeable damage typical of that of brinelling appeared only in one location. The location was at the uppermost position of the bearing when assembled on the vehicle.

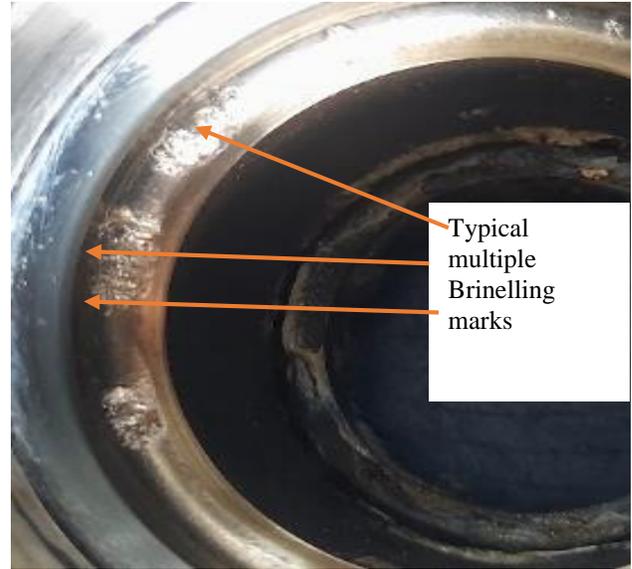
The damage observed on the 46,000 km bearing assembly is shown in Figure 4. A noticeable damage typical of that of brinelling appeared in multiple locations. The location was spread on either side of the uppermost position of the bearing when assembled on the vehicle.

Fig. 4 Damage observed on the 46,000 km bearing assembly

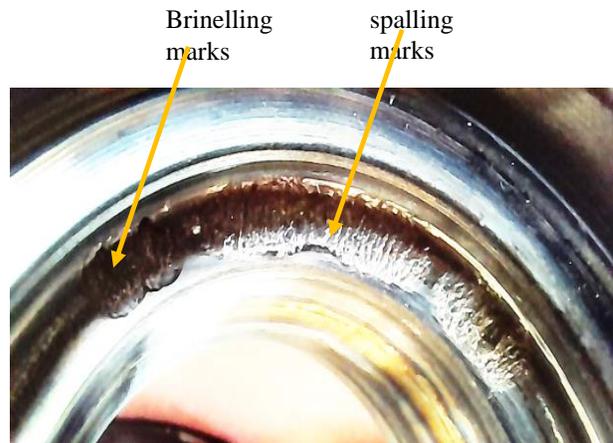
Fig. 5 The damage observed on the 64,000 km bearing assembly

The damage observed on the 64,000 km bearing assembly is shown in Figure 6. Severe damage typical of that of excessive loading was appearing in multiple locations. The location was spread on either side of the uppermost position of the bearing when assembled on the vehicle.

No damage was observed on the outer bearing. However, severe damage was visible on the inner bearing. The damage was predominantly on the outer race. The damage shows that typical damage corresponds to true brinelling [4].

It is clear from the optical image analysis that the profile corresponds to dents created by individual balls of the bearing. This can mainly occur due to true brinelling, vibration-induced fretting damage. According to the literature review, the damage could be due to the quality of material, misalignment during assembly or excessive loading. The

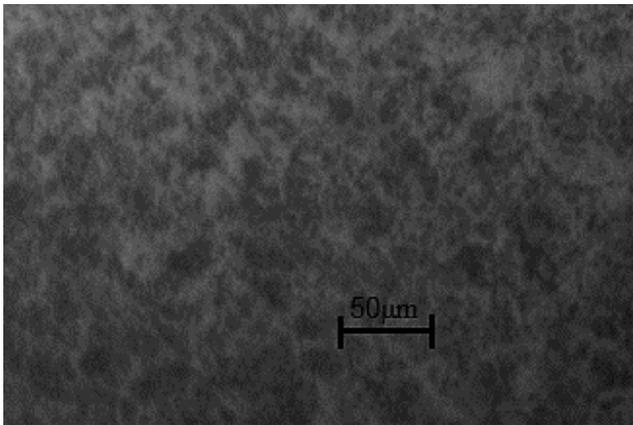
Fig. 6 Microstructure of the case hardened section

The microstructure of the case-hardened section is shown in Figure 6, whereas Figure 7 depicts the microstructure of the core of the material.

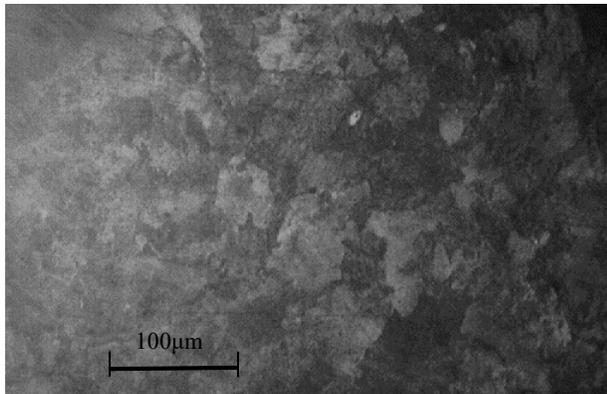
Fig. 7 Microstructure representing the core of the material
