# Materials and Structural Failures Observed after the February 6, 2023 Kahramanmaraş Earthquake in Turkey

Amin H. Almasri<sup>1</sup>, Ahmed M. Abu Abdo<sup>2</sup>, Nader M. Okasha<sup>3</sup>, Omer Mughieda<sup>4</sup>

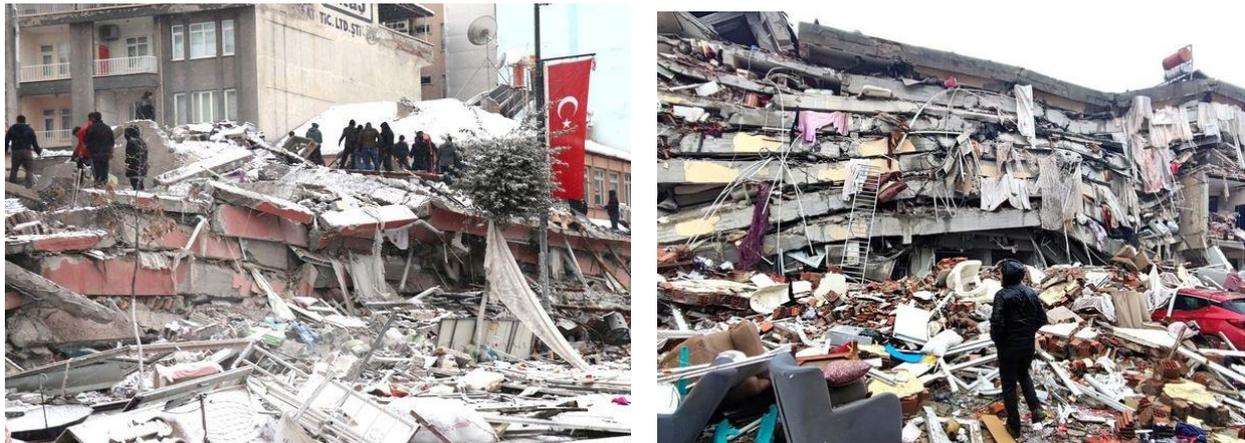
Total shear failure of small reinforced concrete column sections occurs in the absence of significant shear walls. This led to the well-known pancake collapse pattern, either for all stories, as shown in Figure 6, or for lower stories, as shown in Fig. 7, or for an intermediate story, as shown in Fig. 8. Such failures usually result in huge amounts of building waste. Using these huge amounts in new concrete mixes can be feasible, which helps save landfill spaces and have more sustainability in natural resources.

Fig. 6 Pan-cake collapse of buildings in Kahramanmaraş, Turkey. (Sky News, 2023)

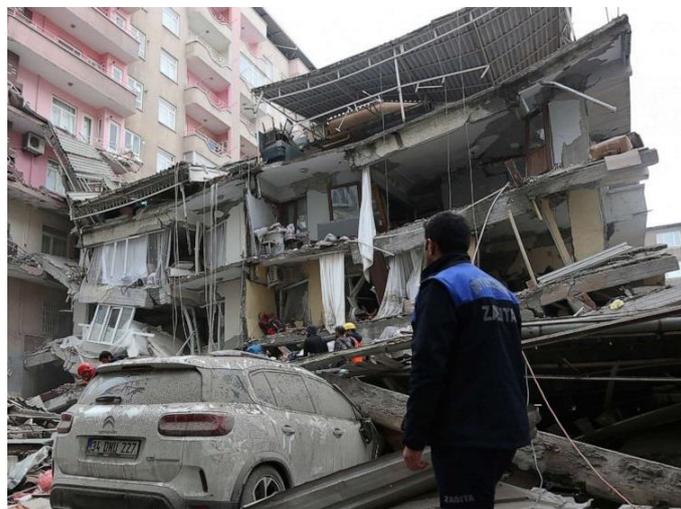
Fig. 7 Pan-cake collapse of a lower-story damaged building in Diyarbakir, Turkey (Sertac Kayar/Reuters)

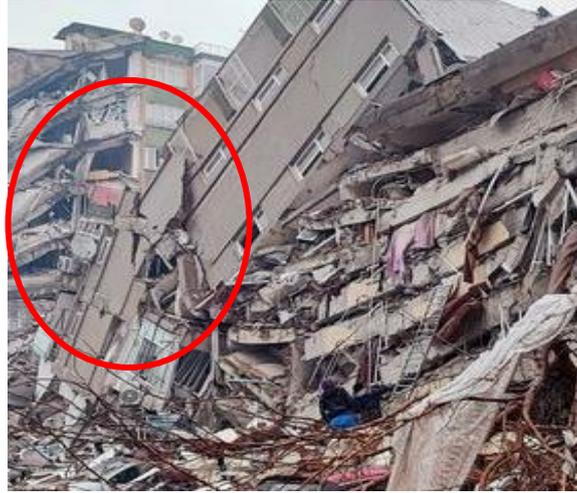
Fig. 8 Pan-cake collapse of the intermediate story of a damaged building in Kahramanmaraş, Turkey (Sky News, 2023)

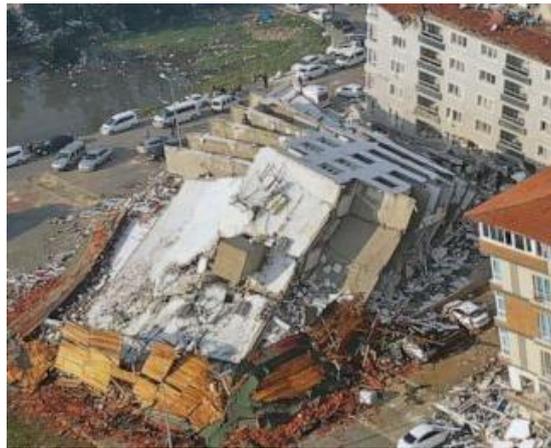
(a)

This can be caused either by failure in some of the story's columns or by geotechnical soil failure under one side of the building. This is illustrated in Fig. 9a, where it looks like the columns on one side of the building have failed, and the whole building is

Fig. 9 An aerial view showing the overturning collapse of two buildings in Hatay, Turkey (Umit Bektas/Reuters)

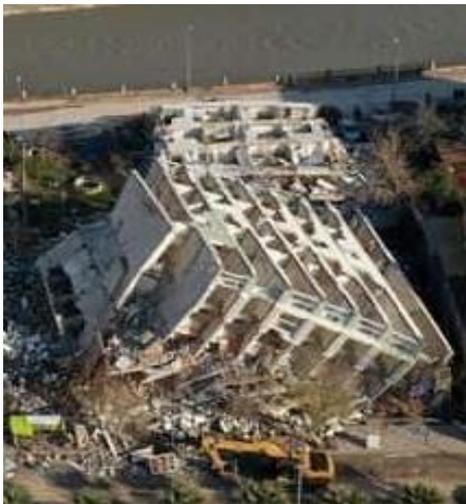
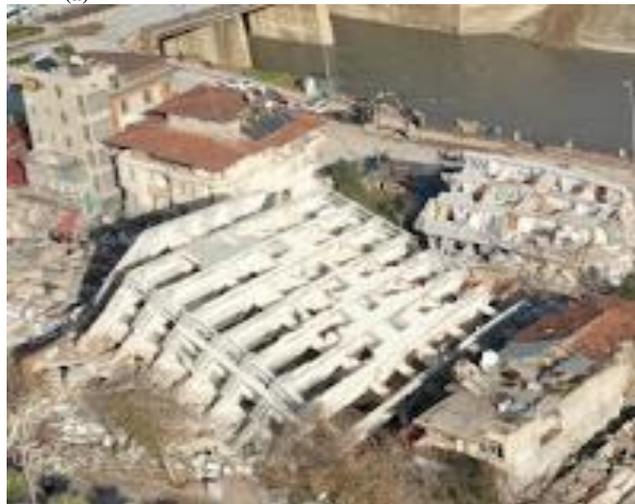
(b)

overturned. The building slabs seem distorted due to the columns' failure. Another overturned building is shown in Fig. 9b but with less distorted slabs. This could indicate a geotechnical soil failure in the form of liquefaction, especially since the building is close to a water source.

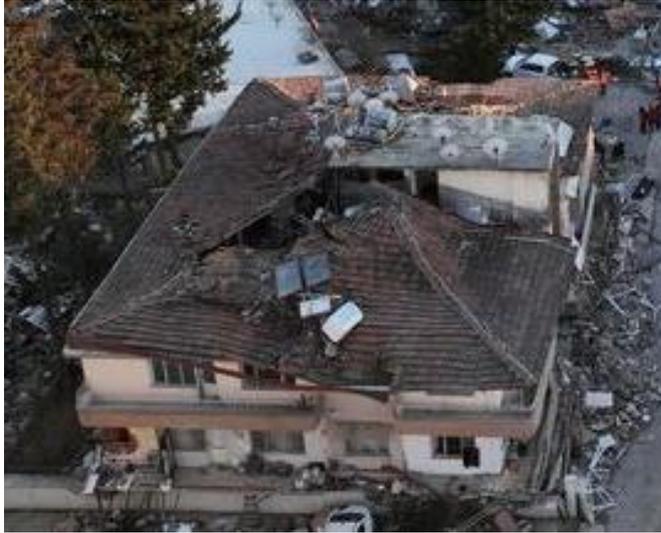
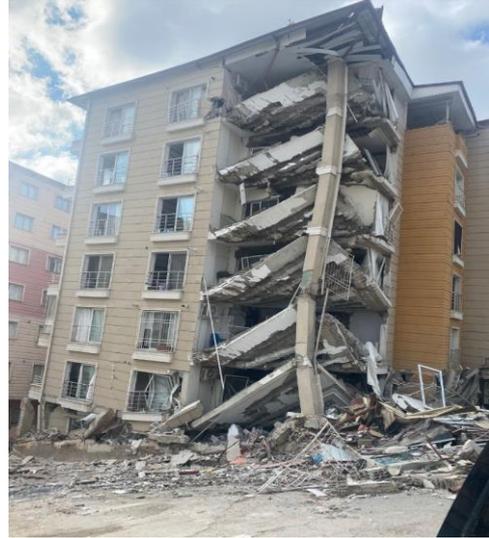
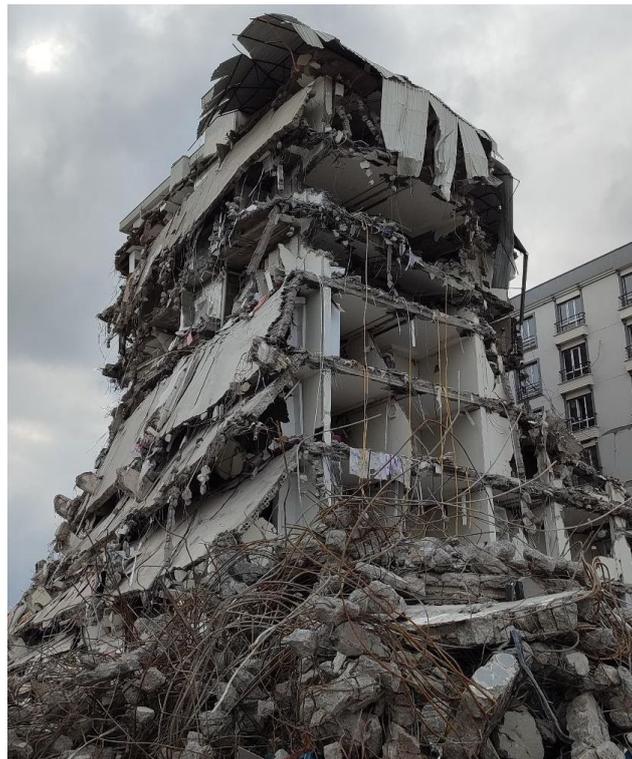
Failure of one part of the building would occur while the rest of the building is still standing, as illustrated in Figure 10. Apparently, the stiffness of

one side of the building is lower than the rest of the structure, which led to the partial collapse. Such asymmetry in building and structures are unfavourable in such active seismic zones and should be avoided or properly designed for the anticipated seismic activity.

Fig. 10 Partial collapse of buildings in (a) Hatay, Turkey (REUTERS/Emilie Madi), (b) Hatay, Turkey (Cem Yenidogan/LinkedIn), (c) Nurdağı district, Turkey. (Egemen Sönmez/LinkedIn)

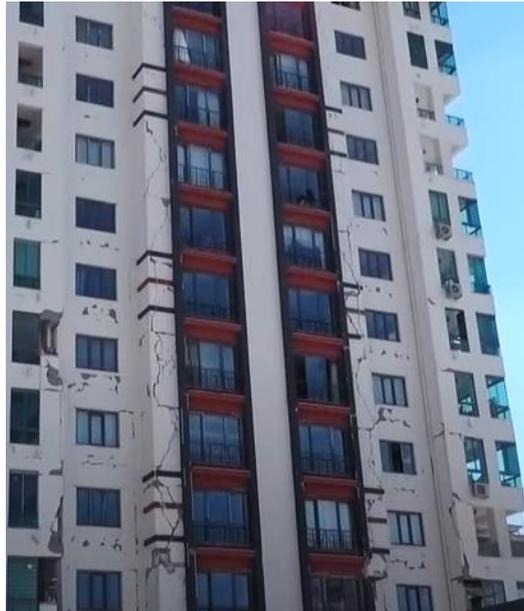
This was captured in a building in Malatya, as illustrated in Fig. 11. Apparently, the torsional

vibrational mode was significant in this building during the earthquake. It could be the reason behind the collapse of many buildings.

Fig. 11 Torsional cracking of concrete columns in a building in Malatya, Turkey. (Ihlas News Agency, 2023)

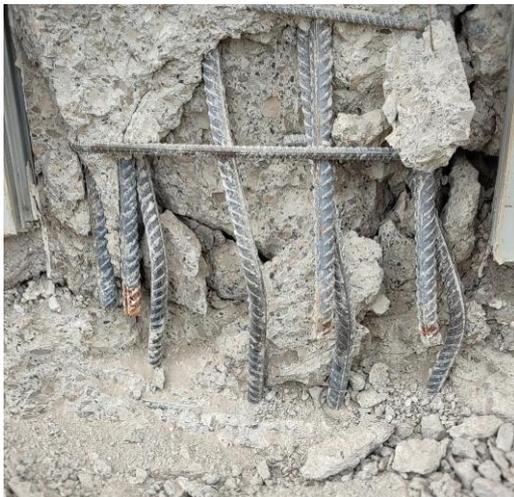
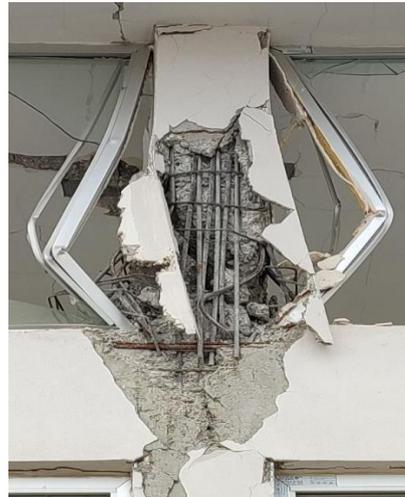
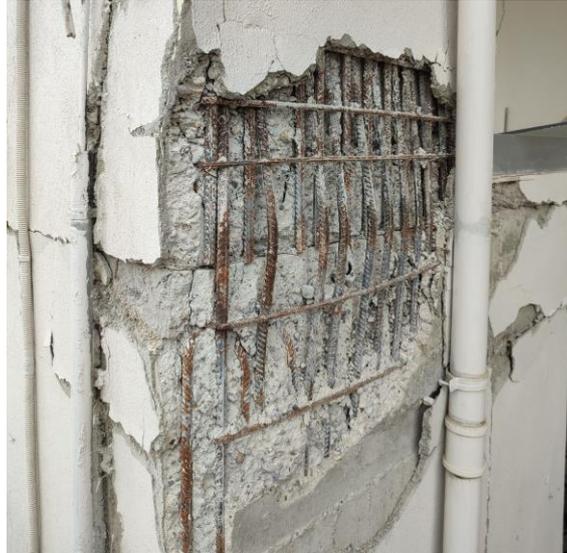
Despite the fact that longitudinal steel reinforcement in columns and walls mostly looks appropriate, large and inappropriate tie spacing was noticed in many pictures of the buildings columns and walls, as can be seen in Fig. 12, 13, and 14.

During the earthquake, the concrete usually disintegrates, adding higher axial compressive loads on the longitudinal steel bars on the one hand and losing the lateral confinement for the longitudinal bars on the other hand, causing the longitudinal reinforcement bars to buckle on short lengths. The good thing is that longitudinal bars showed high ductility and deformation, indicating good reinforcement bar quality.

Another problem with the ties is that they are executed with a 90-degree ending hock instead of the required 135-degree ending hock. This led many ties to open during the earthquake and lose the axial confinement of the element. In addition, no stirrups-densified end zones were seen in most of the columns and walls, as per seismic code requirements.

The lack of such reinforcement details prevented the columns from manifesting the higher levels of ductility they needed during the earthquake. It also prevented the columns from forming plastic hinges near the joints, which could have prevented many brittle column failures.

**Fig. 12** Large tie spacing is noticed in buildings in the Nurdağı district (Egemen Sönmez/LinkedIn)

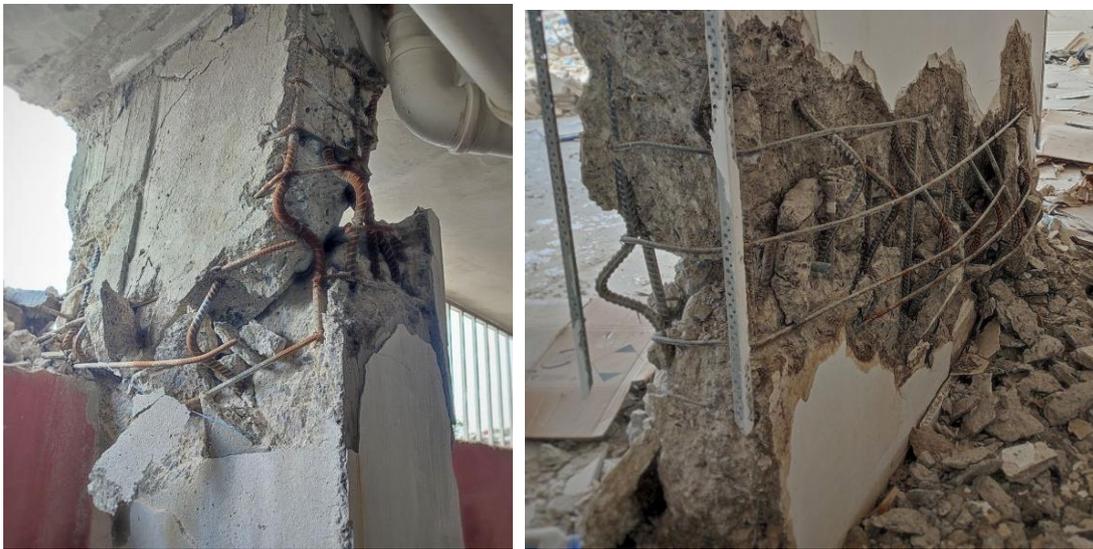
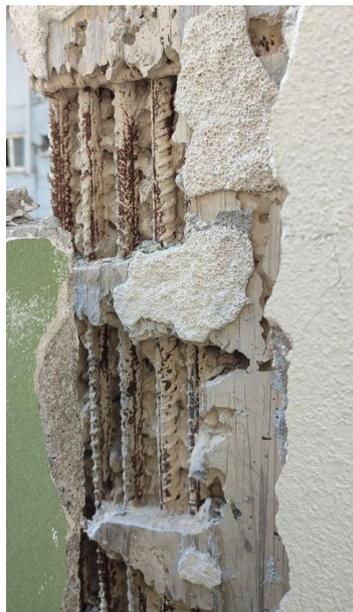
**Fig. 13** Large tie spacing is noticed in buildings in the Türkoğlu district (Egemen Sönmez/LinkedIn)

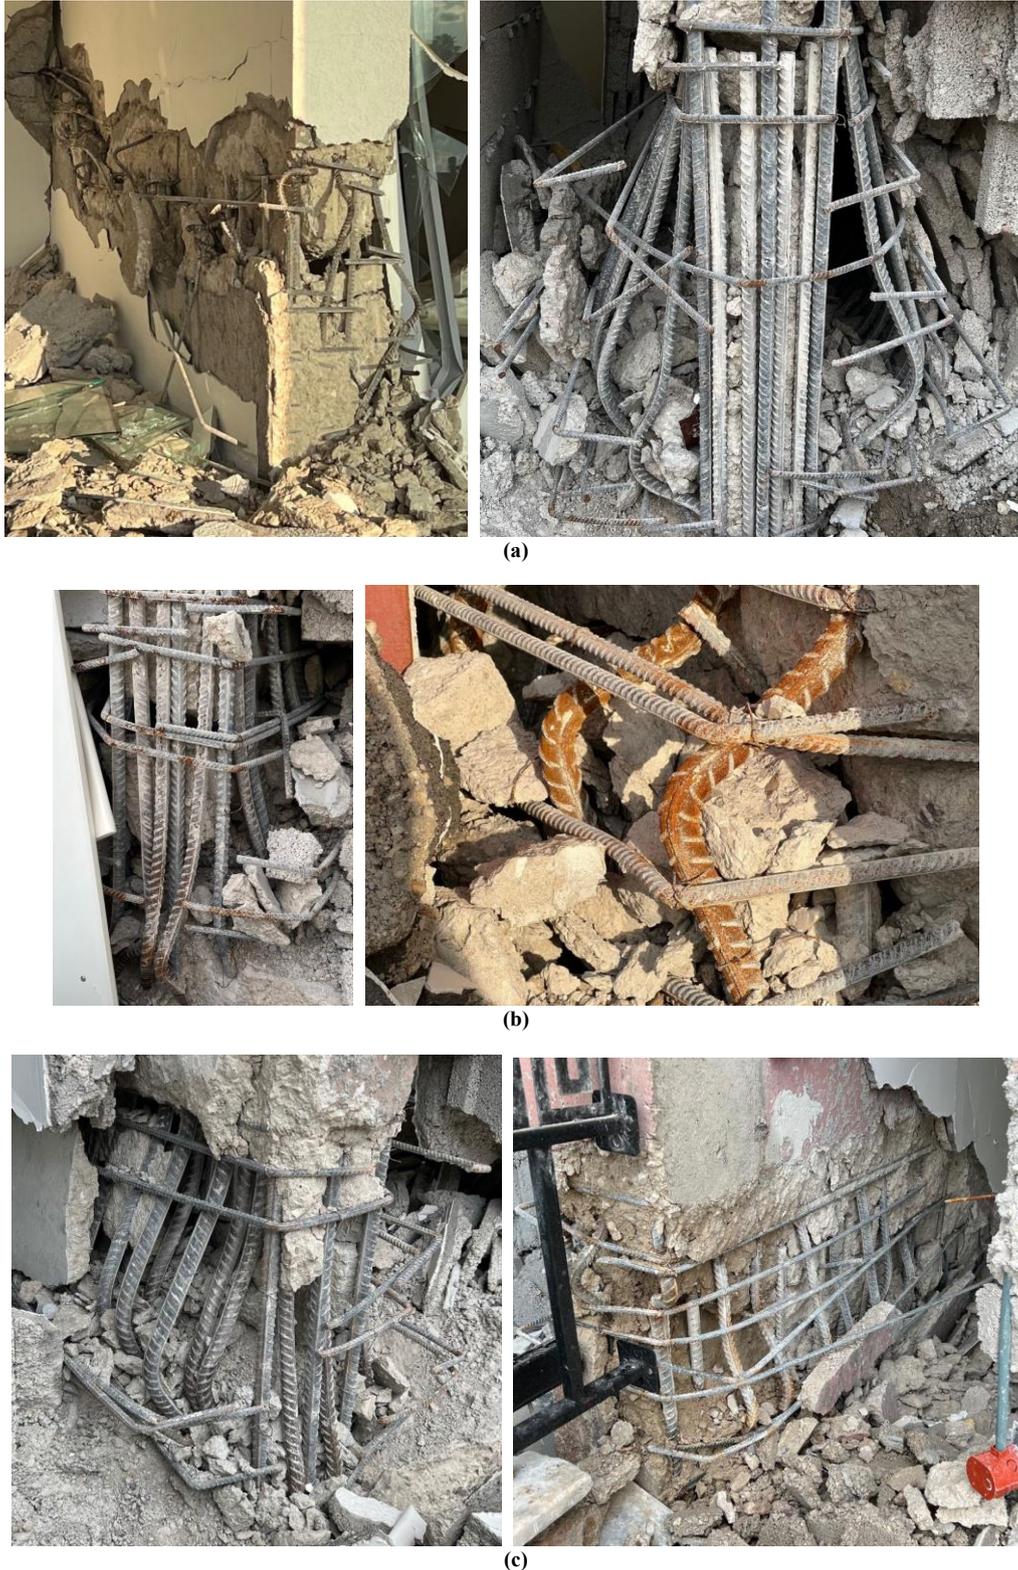
Fig. 14 Damages and buckling in columns reinforcement in Hatay (Cenk Ustundag/LinkedIn)

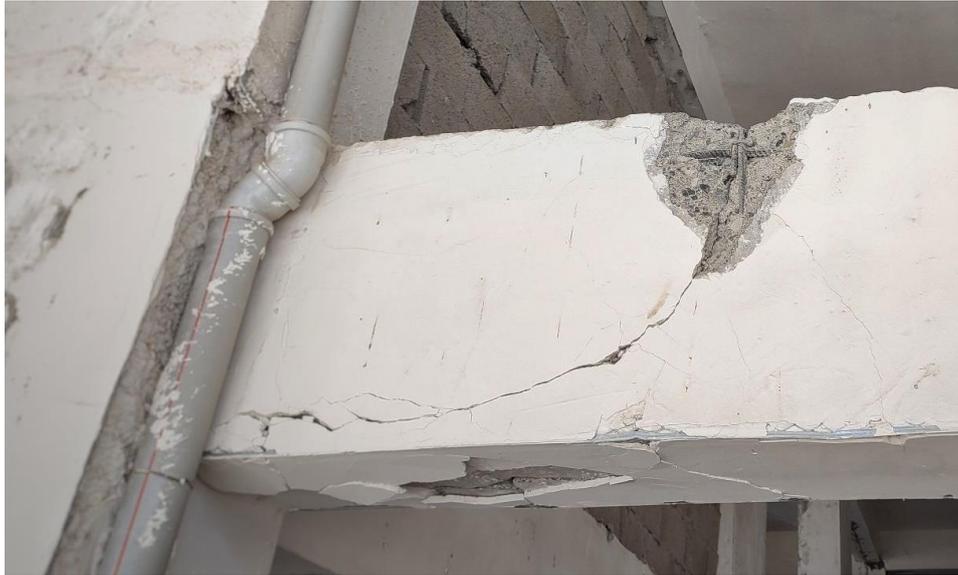
The earthquake has raised the stresses significantly in beams, leading to shear failure, as seen in Fig. 15, or to excessive compressive stresses, leading to buckling and eventually rupture of longitudinal steel bars at the bottom of the beams, as

Fig. 15. Near support shear failure in concrete beams in a building in (a) Türkoğlu district and (b) Nurdağı district (Egemen Sönmez/LinkedIn).

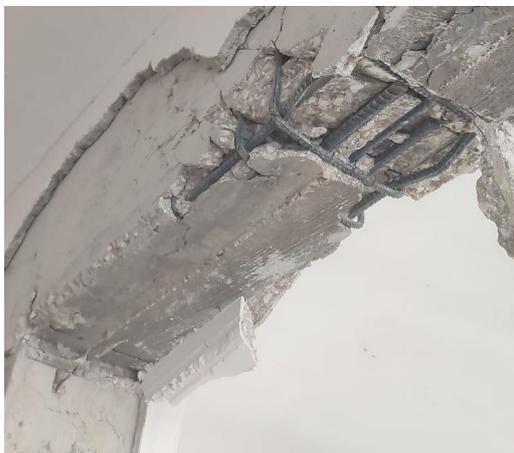
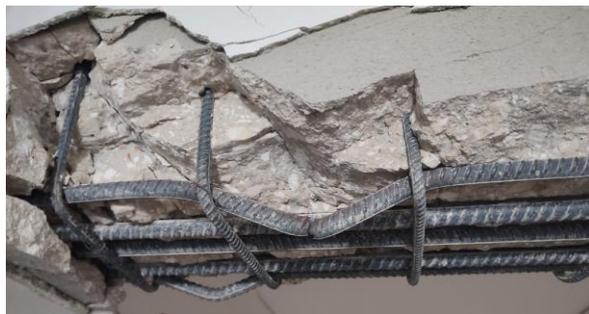
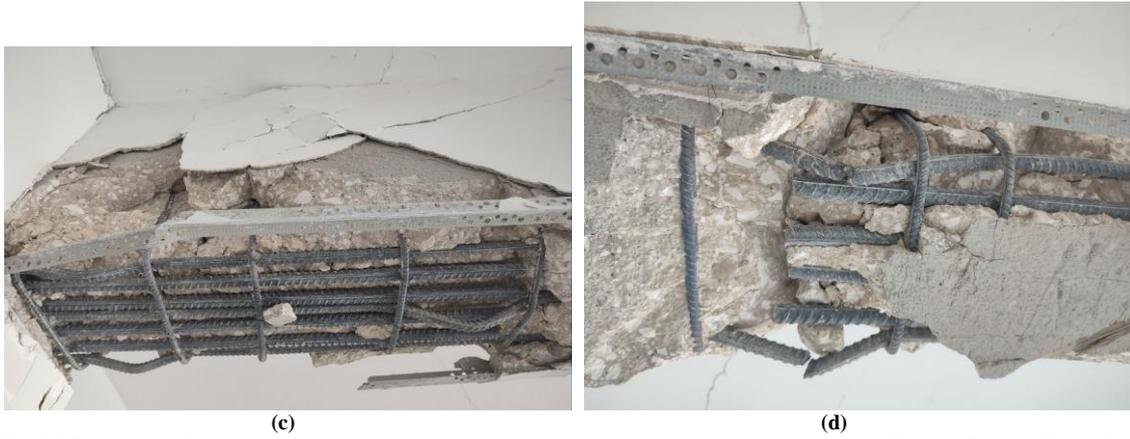
seen in Fig. 16. The bottom concrete cover is usually separated from the beams. The spacing of the beams' stirrups (designed to resist shear) was insufficient to provide lateral confinement for longitudinal bars against local buckling. It is also clear that there is a debonding problem between concrete and steel bars.

Fig. 16 Buckling and rupture of bottom steel reinforcement bars in a building beam in Antakya. (Egemen Sönmez/LinkedIn)

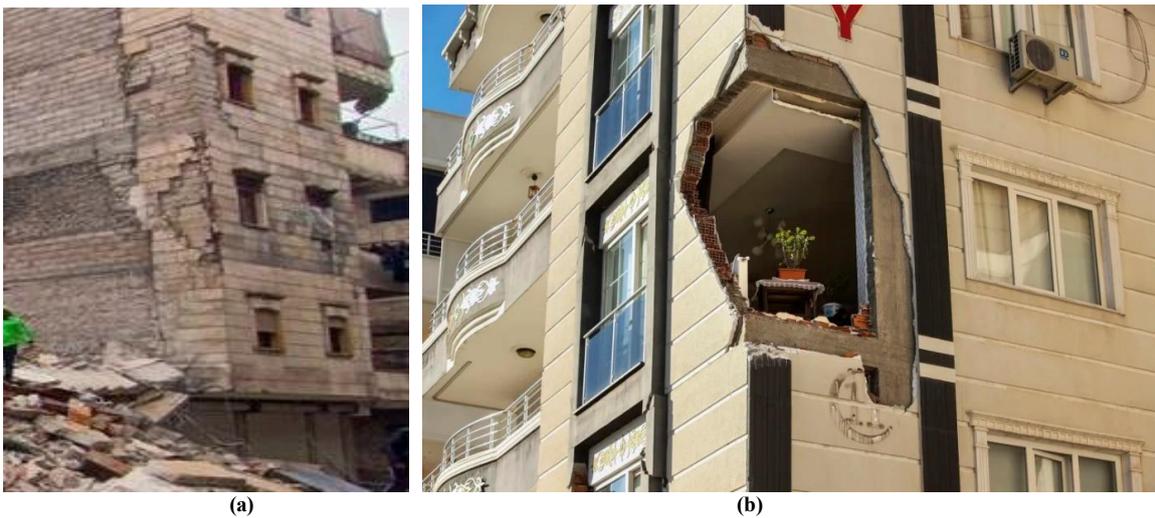
This is illustrated in the buildings shown in Figure 17. The façade was not restrained appropriately to the building's structure, which does not comply with seismic provisions requirements. In addition, the falling of ribbed slab blocks was observed in one

Fig. 17 Peeling off of façade in a building (a) in Aleppo, Syria (Sky News, 2023), (b) in Adiyaman, Turkey. (Emrah Gurel / Associated Press)

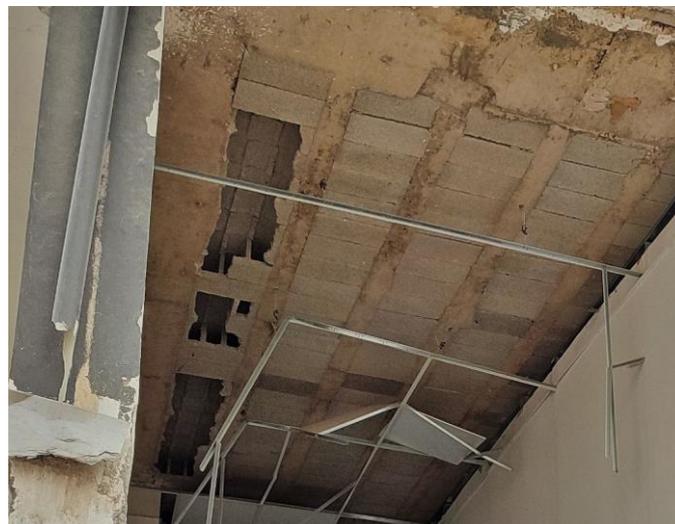
building in the Nurdağı district (Fig. 18). This could impose serious life-threatening risk since these blocks are considered heavy falling objects, even though the structural system could be safe in the event of losing these blocks.

Fig. 18 Falling of ribbed slab blocks in a building in Nurdağı district. (Egemen Sönmez/LinkedIn)

- Using typical cement-made blocks in ribbed slabs can impose life risks on building occupants. They can either be replaced by lightweight blocks such as polystyrene blocks, or another slab system can be used.
- Bridges seem to miss seismic requirements, such as lateral diaphragms and girder stoppers. These should be enforced and applied in all bridges in active seismic zones.
- As earthquakes cause bending and misalignment to train rails, it is important to develop a detection and alarm system that can stop trains in the event of a strong earthquake to avoid train derailment and, eventually, losses.
- Road pavements suffered hugely from the earthquake in the form of cracking and slicing. Using high ductility modified asphalt binder, such as rubberized asphalt or fiber reinforced asphalt mixes, is recommended to increase the resistance to deformation due to earthquakes.

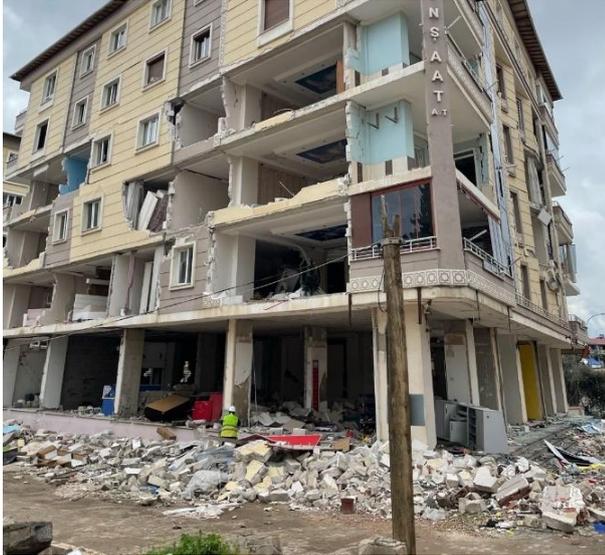
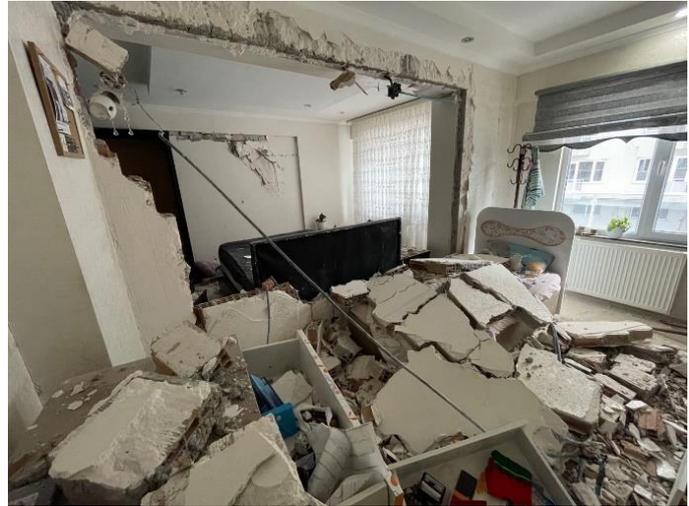
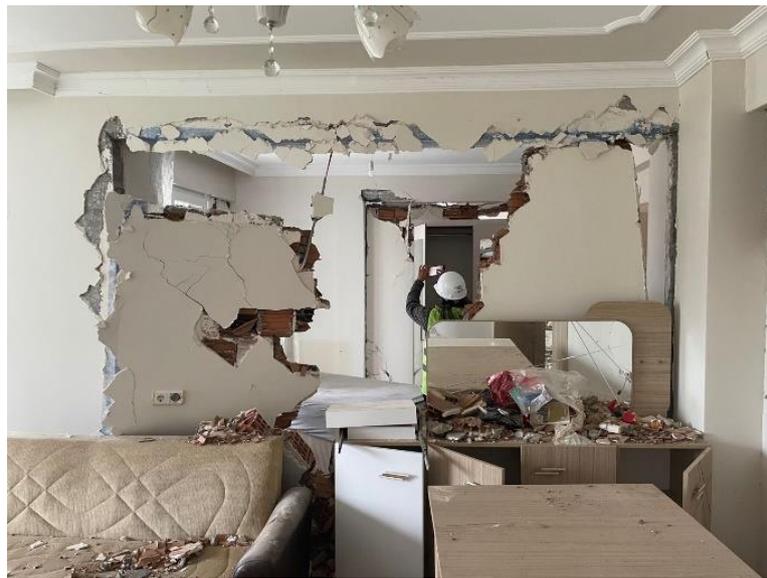
masonry walls cracked or crumbled. A sample building is shown in Fig. 19. Much research (for example, Murty and Jain (2000) and Elouali (2008)) have been conducted on the effect of masonry walls on the seismic performance of building frames.

Fig. 19 Masonry infill walls failure and fallout (Mike Mieler/LinkedIn)

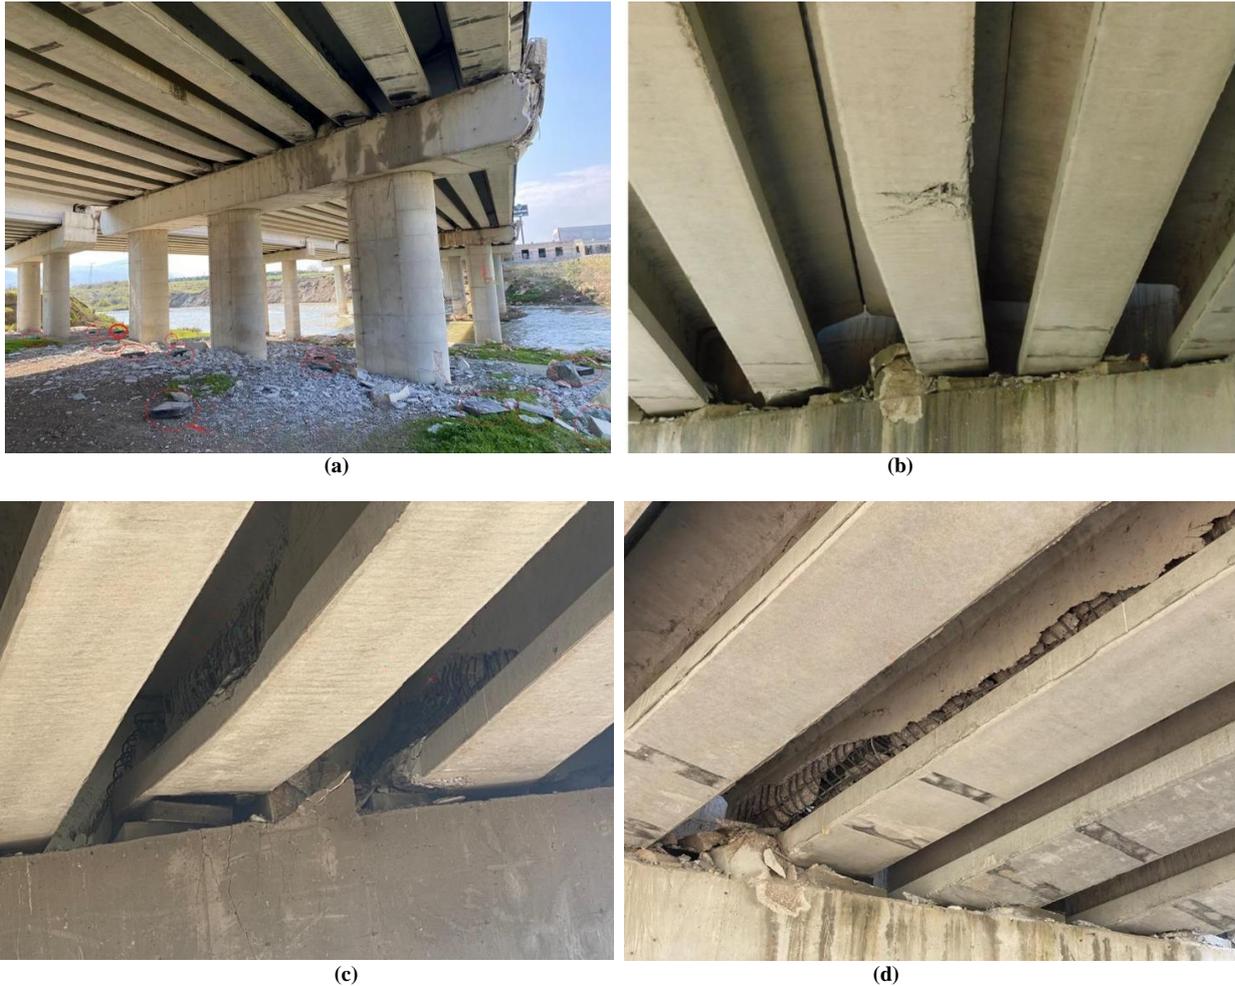
This was observed in the girders of the Hatay State Hospital Road bridge in north Antakya, Turkey (Fig. 20). Lateral diaphragms were missing in the bridge, which in turn allowed lateral displacement and deformation of the beams to take place. The webs of girders were heavily damaged, which could indicate the development of high shear stresses in the webs during the earthquake. Similar bridges are expected to be constructed the same way around the country and

hence can be seismically vulnerable. They should be checked, and lateral diaphragms should be added as necessary. Rubber bearing pads were noticed on the ground, as they were not appropriately fastened to the bridge structure. There are also no girders stopers at the piers to prevent girders from moving laterally and hitting each other. It is clear that the bridge lacks the application of some seismic provisions' requirements. These damages are similar to those reported by Kawashima et al. (2011).

Fig. 20 Damage in concrete bridge parts (Farzad Haghi/LinkedIn)

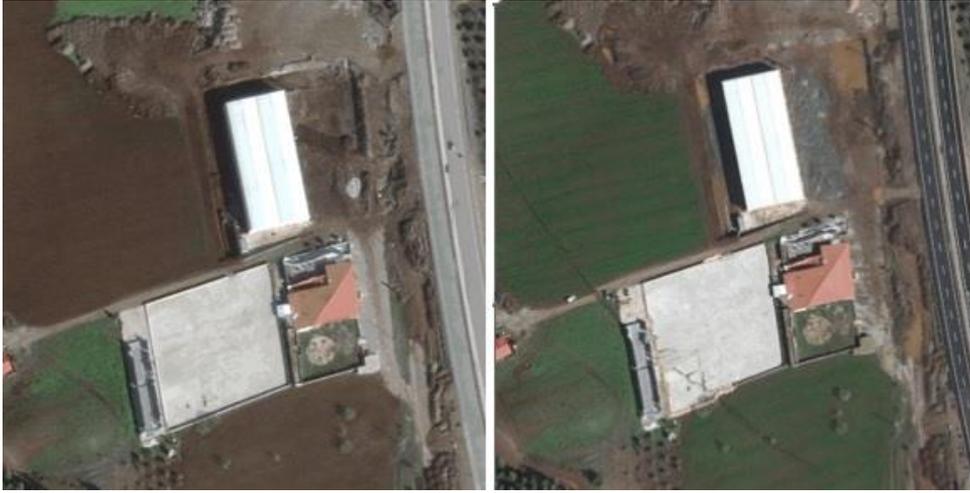
The fault line deformation and movement caused some damage, as seen in the building in Altinuzum, as shown in Fig. 21. Although the earthquake vibration could not collapse the building, the fault line movement cracked and separated the corner of the building. Also, the movement of the fault line causes damage to a railway between the Türkoğlu district of Kahramanmaraş and the İslahiye district of Gaziantep, as shown in Fig. 22. Major earthquakes may cause multiple types of damage to railways, such as slippage, bending, misalignment due to the shaking and failure in the supporting subgrade resulting in trains derailment and suspension of operations (Byers, 2004). It is a major safety concern since moving trains will be affected and may derail, leading to accidents and loss of lives (Cmsadmin, 2011). In Turkey, the railway network has 10.68 billion passenger kilometres in passenger traffic (WorldData, 2023). More than 1,275 km of railways, passing 11 provinces, were damaged due to this earthquake. The total damage, including

Fig. 21 A satellite image shows a building before and after the earthquake, where a fault line damaged the building, in Altınuzum, Turkey. (Reuters)

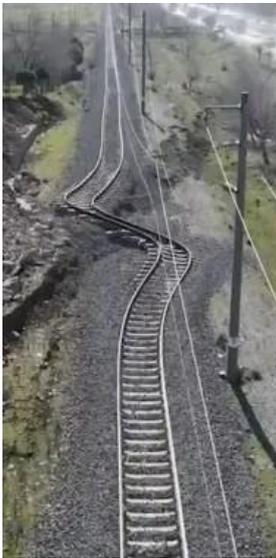
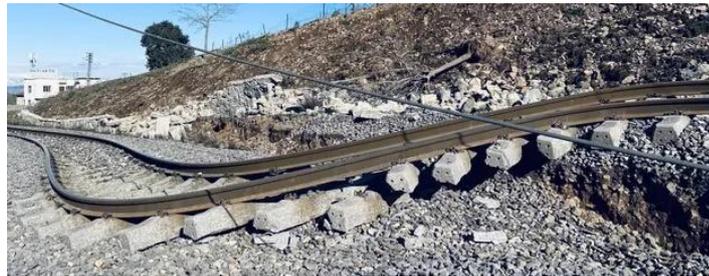
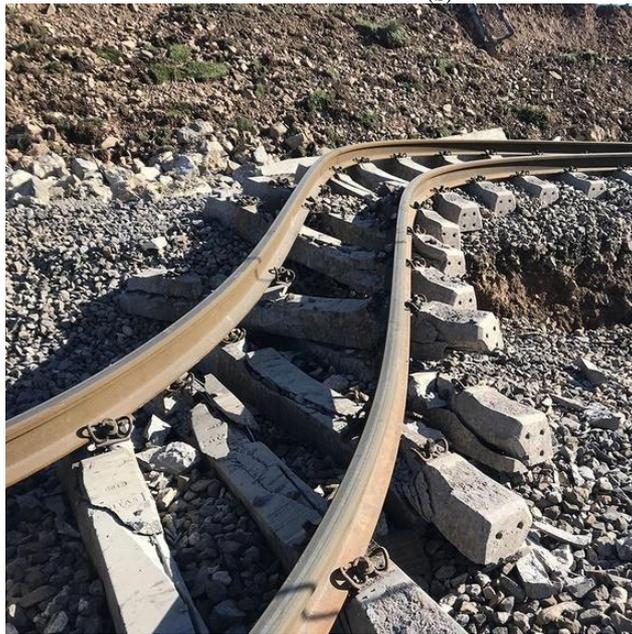
railways, electric, phone lines, rail stations, bridges, tunnels, and signal and communication facilities, was estimated to be around 785 million US dollars (Artymiuk, 2023). Furthermore, some areas' landslides occurred along the railways and affected the railway's operation (Fig. 23).

Fig. 22 A damaged train track between the Türkoğlu district of Kahramanmaraş and the İslahiye district of Gaziantep. Photograph: (a) and (b) Anadolu Agency/Getty Images, (c) Harber|Global, 2023

Even though railway damage due to earthquakes may not be avoided, measures should be implemented to avoid loss of lives due to the derailment of trains during an earthquake, especially high-speed passenger (bullet) trains. In Japan, which is well known for experiencing frequent major earthquakes, a detection and alarm system (UrEDAS) is utilized to detect earthquakes and predict the expected effects and severity. UrEDAS consists of seismometers installed at 97 locations in the country. Based on the severity of a detected earthquake, the system will transmit warning signals to shut down the power supply, stopping trains. This system is designed to reduce the derailment of moving electric passenger trains, hoping to save lives (Cmsadmin, 2011).

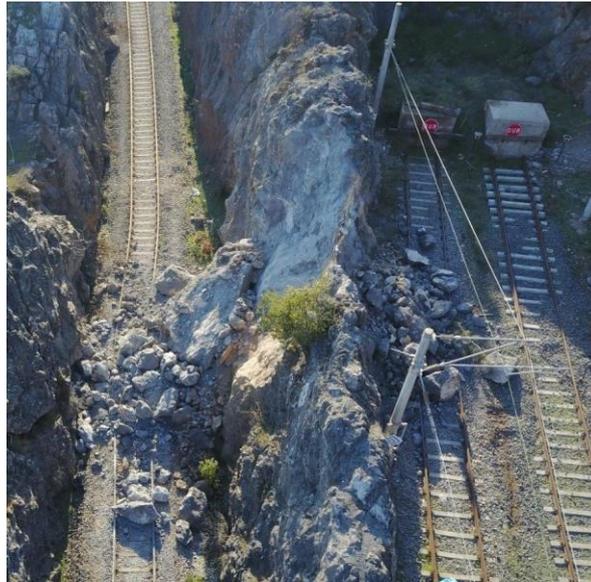
Fig. 23 Landslide near Fevzipaşa train station, Gaziantep, Turkey (After Daily Sabah with DHA, 2023)

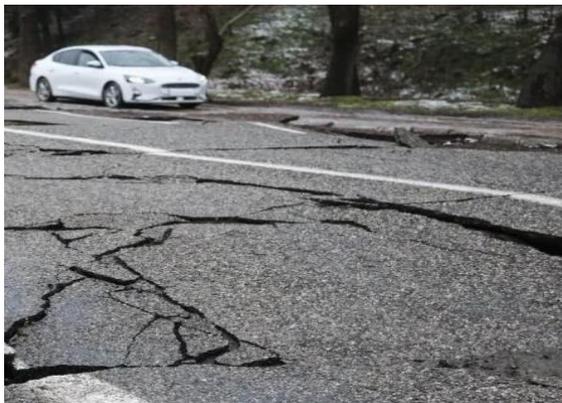
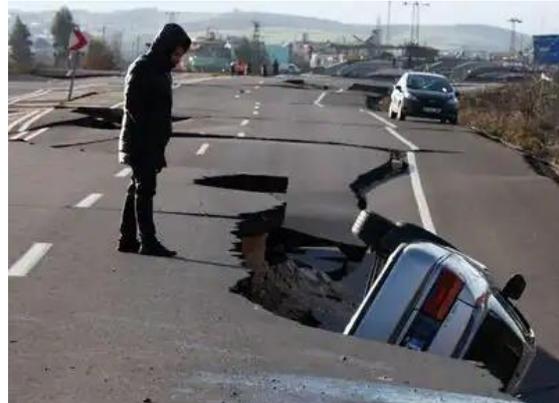
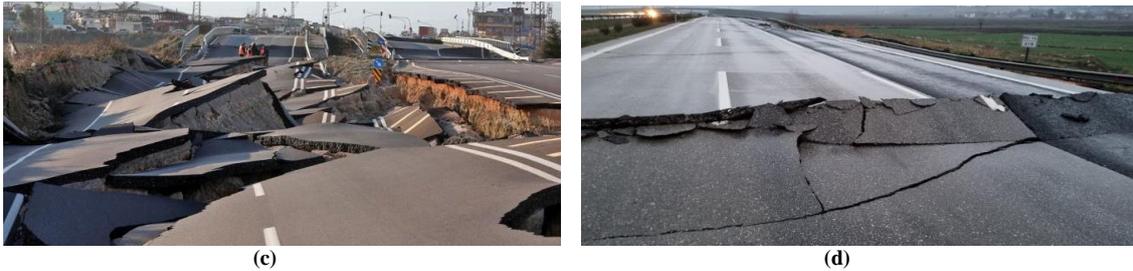
Fig. 24. Damaged roads in (a) Fevzipasa, Turkey. (Emin Sansar / Anadolu Agency), (b) Demirkopru village (Reuters), (c) D420 road in Demirkopru. (Benoit Tessier / Reuters), (d) the Tarsus-Adana-Gaziantep (TAG) Highway.

Different methods can be adopted to repair damaged pavements, including sealing, patching,

resurfacing, or a total reconstruction (Yin et al., 1997), which do not differ from normal repairs of pavements. However, this will cause a massive strain on rebuilding costs and efforts, but it cannot be avoided. Repairing road networks is essential for rebuilding efforts (transporting equipment and construction materials). Different approaches to designing roads in frequently earthquake-affected regions should be evaluated and implemented to reduce the effects of an earthquake on roads. Using high ductility modified asphalt binder, such as rubberized asphalt or fiber-reinforced asphalt mixes, will increase the resistance to deformation due to earthquakes. Adding rubber-derived aggregates to asphalt mixes or unbound subbases may absorb the shocks resulting from an earthquake. In addition, increasing the stability of subbases and subgrades should be considered. Incorporating geogrids between pavement layers may reduce the shifting of unbound materials due to the shaking and vibrations induced by an earthquake. Thus reducing the damage to pavements and repairing efforts.
