# Pavement Failures And Its Rehabilitation

**Abstract**— Now-a-days roads are destructed due to weather conditions, traffic volume and heavy good vehicles. So, we have planned to do project on road rehabilitation and maintenance. We have selected a road to do project which is damaged with potholes, raveling etc. We will found the causes of failures on the road, and conduct lab tests on materials which were used for constructing that existing road to know the quality of the materials. we have conducted traffic survey which will help to know some more causes of the pavement failures.

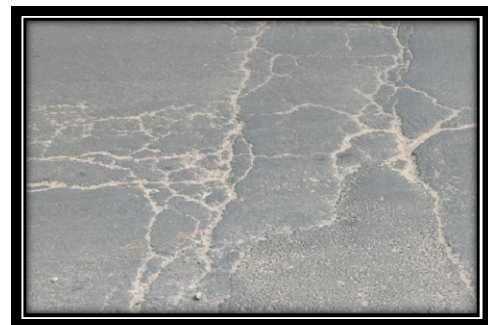
Fig 1: Alligator cracking

Alligator cracking is a load associated structural failure. It often starts in the wheel path as longitudinal cracking and ends up as alligator cracking after severe distress.

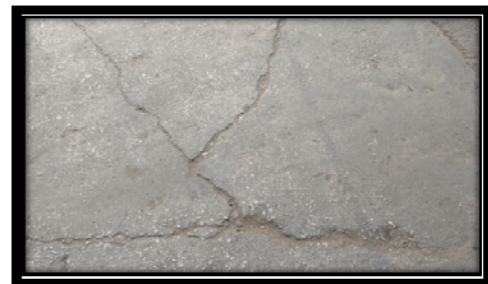
Fig 2: Block Cracking

Generally this type of cracking occurs due to Using of old (or) dried out mix, Mix was placed too dry, Fine aggregates mix with low penetration asphalt and absorptive aggregates.

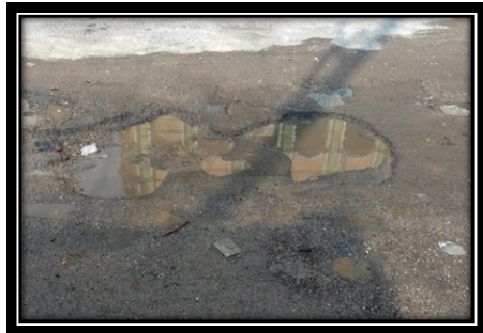
Fig 3: Pot Holes

It Causes Poor drainage, Weak sub base or sub grade. It is very dangerous for two-wheeler vehicles and other vehicles too.

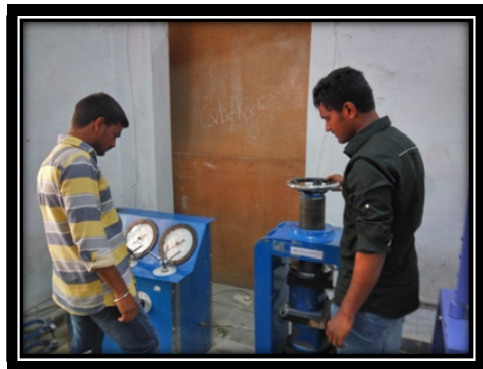
Fig 5: Finding crushing value of the aggregates

The standard crushing value should be,

- 1) Surface - less than 30%
- 2) Base course – less than 40%
- 3) Sub base course – less than 50%

The mean of the crushing value obtained in the two tests is reported as the aggregate crushing value 0.98%.

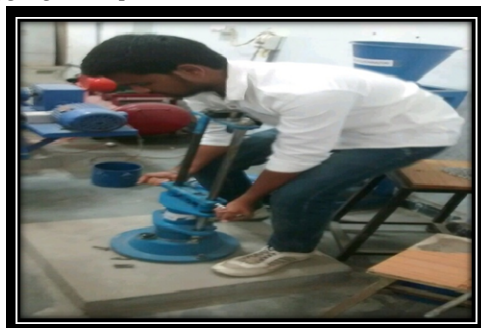
Fig 6: Finding Impact value of the aggregates

Aggregate impact value is to classify the stones in respect of their toughness property as indicated below:

Total aggregate weight (w1) = 360 grams

Aggregate weight passing through 2.36 mm sieve (w2) = 72 grams

Aggregate impact value (%) =  $w2 / w1 * 100 = 20\%$

From the above results, we can say that the aggregates are enough strong.

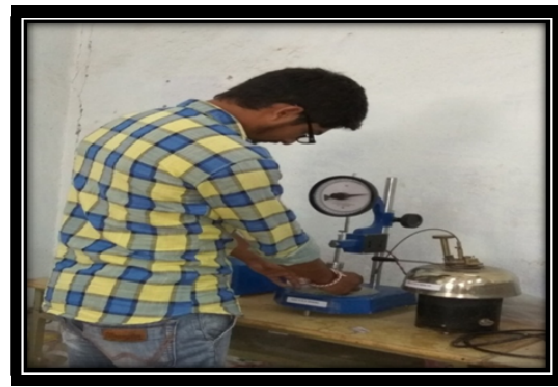
Fig 7: Finding penetration value of the bitumen

Penetration reading is 64

The difference between the initial and final penetration readings is taken as the penetration value. The mean value of three penetration measurements is reported as the penetration value.

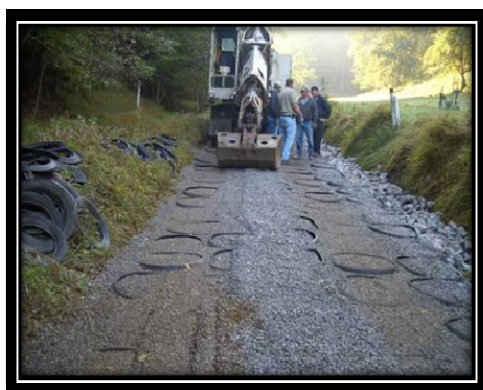
Pothole terminator by mechanical concrete takes crushed stone and puts it inside a thin walled cylinder, which is a tire with its side walls removed, and then it is covered up.

So when we confine this aggregate, it is solid .it is not going anywhere . we can put asphalt, concrete or even more stone over it. Once installed, the now fixed road way is permeable, allowing water to run through it without causing damage.

Now it is like a structural French drain. A French drain is essentially a trench filled with gravel or rock or perforated pipe that redirects surface water and ground water away from an area. Much like the pothole terminator by mechanical concrete, French drain prevent ground and surface water from penetrating or damaging a foundation or in this case, the roadway base.

Fig 8: Process of Pot hole terminator

- 1) The potholes, ravelling occurs mainly due to weak sub grade and base course. So, using of Pothole terminator by mechanical concrete method (explained above), we can decrease the potholes and ruts and drainage problem too. This is applicable for both bitumen and concrete road.
- 2) The cracks will be healed when the cracks are in minor stage on the self-healing roads and this is very useful in rainy season. These can reduce the pollution by using more fly ash with cement and this is the concrete road.
