# Road Safety Audit: A Case Study of Rural Road on SH 117 in Ramanagara District, Karnataka

V. Pampapathi<sup>1</sup>, T. R. Nikhil<sup>2</sup>, Yateen Lokesh<sup>3</sup>

This article provides the results of a preliminary design stage road safety audit of a proposal to duplicate 9km of State highway in SW Karnataka.

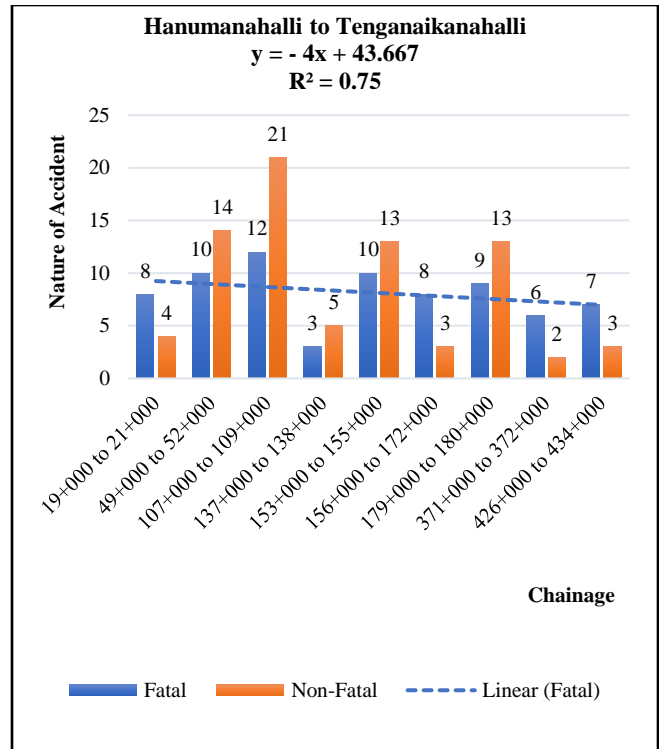
Fig. 4 Regression analysis of accident data

Note :A regression model was developed to analyze the relation between no. of accidents and fatal accidents which is occurring on identified black spots.

- A linear trend was observed to be the worst-fit equation with a coefficient determination value below 0.5.
- The polynomial trend was observed to be the best fit with the coefficient of determination 1, i.e.  $R^2 = 1$ .

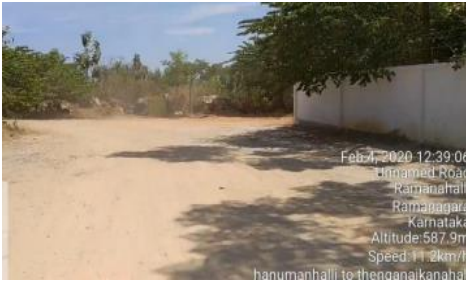
SL No.	Chainage	Site Photos	Description of Road Issue	Recommendation as per IRC	Road Safety Risk Assessment
1	19+000 to 21+000

<b>Horizontal Curve</b> Poor sight distance at a curve causes the risk of the head-on collision	Provide curve warning sign boards as per IRC:67-201	High
2	15+600 to 17+200

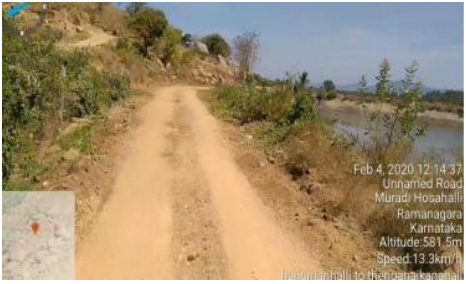
<b>Waterbody/tank/nala on LHS of carriageway</b> Errant vehicles may fall into the canal.	Metal Beam Crash Barrier to be provided along the road as per IRC: SP: 88-2019	High

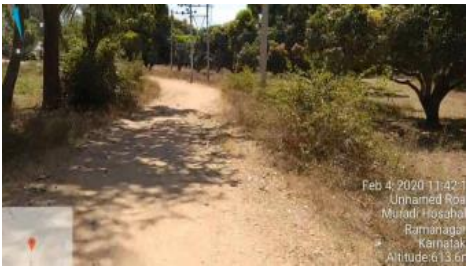
<p>3</p> <p>17+900 to 18+000</p>

<p><b>Horizontal Curve</b> Poor sight distance causes the risk of the head-on collision</p>	<p>Provide Curve Warning Sign as per IRC: 67 - 2012</p>	<p>High</p>
<p>4</p> <p>37+100 to 37+200</p>

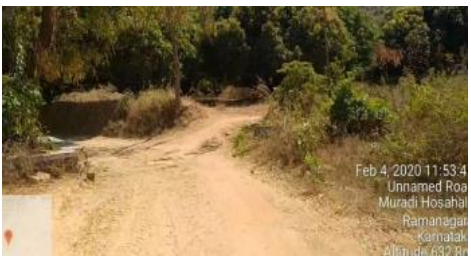
<p><b>Horizontal Curve</b> Poor sight distance at a curve causes the risk of the head-on collision</p>	<p>Provide Curve Warning Sign as per IRC: 67 - 2012</p>	<p>High</p>
<p>5</p> <p>56+200 to 56+400</p>

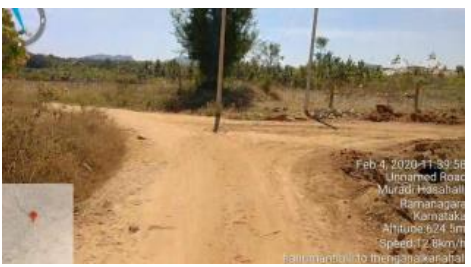
<p><b>Y Junction Point</b> Possible collision with the through traffic.</p>	<p>Provide Cautionary Sign boards indicating junction ahead as per IRC 67-2012</p>	<p>High</p>
<p>6</p> <p>86+100 to 86+200</p>

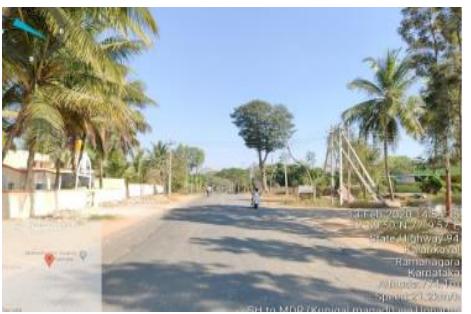
<p><b>Design of Start Point/T Junction</b> Possible collision with the through traffic.</p>	<p>Provide junction warning sign boards as per IRC:67-2012</p>	<p>High</p>
<p>7</p> <p>87+850 to 87+900</p>

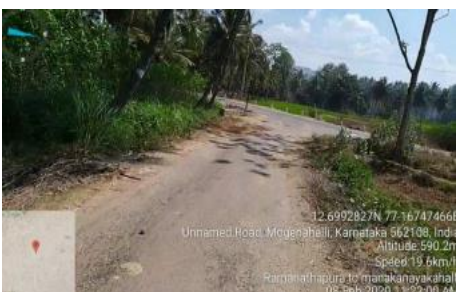
<p><b>T - Junction Point/End Point</b> Possible collision with the through traffic</p>	<p>Provide junction warning sign board as per IRC:67- 2012</p>	<p>High</p>

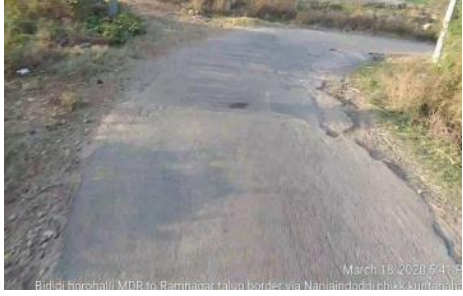
8	99+600 to 99+850

<b>Sharp Horizontal Curve</b> Poor sight distance causes the risk of the head-on collision	Provide Curve Warning Sign as per IRC: 67 - 2012	Very High
9	121+000 to 121+400

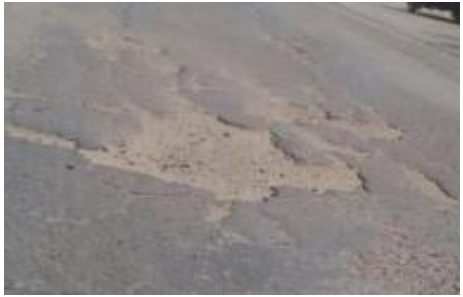
Formation of ruts, cracks, and potholes.	Cracks and potholes. The road should be repaired immediately.	High
10	45+000 to 46+000

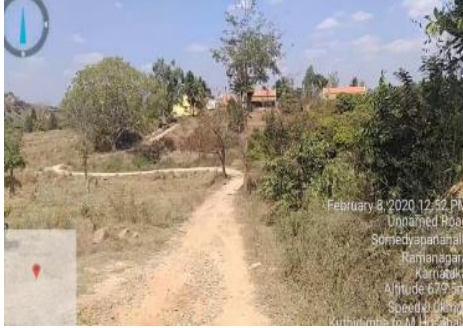
<b>S-Curve</b> Poor sight distance at the curve causes the risk of a head-on collision	Provide Cautionary Sign boards viz S curve ahead as per IRC 67-2012.	High
