Original Article

Stability of Fractured Rock Massifs: Geotechnical Characterization: Case of the Excavation N°11 of the Taza-Al Hoceima Expressway in Bouârma. (Al Hoceima, Northern Morocco)

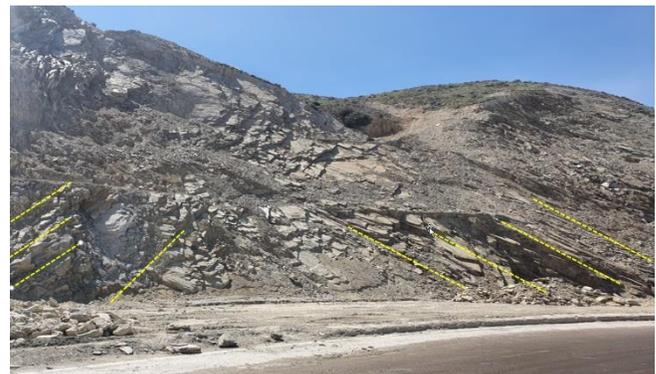
Fig. 1 Fractured rock, the rif mountains, morocco

Indeed, the stability of rock masses depends not only on the nature of the in-situ ground but also on the fracturing network, characterized by its roughness, joint nature, density, and the arrangement of discontinuities relative to the slope faces. Thus, understanding and predicting the behavior of rock masses under various conditions and technical constraints is critical for ensuring the safety of infrastructure, particularly in the domain of rock mass classification [2]. This is particularly true for projects planned in mountainous regions dominated by fractured rocks (Figure 1), such as in the Moroccan Rif,

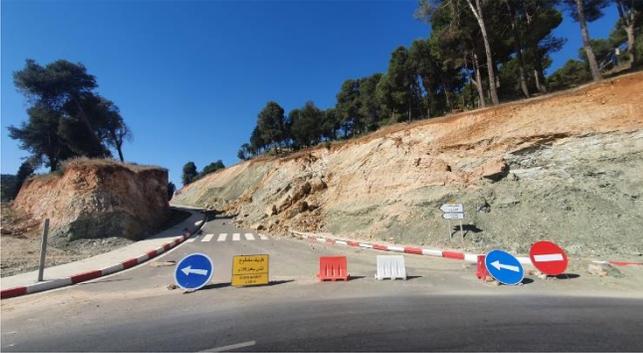
Fig. 2 Instability of a rocky slope in northern Morocco; the road has been diverted due to these instabilities

For instance, the photo below illustrates a typical case of rock slope instability in northern Morocco (Figure 2). This collapse necessitated the diversion of the RR607 road connecting the city of Berkane to the Fes-Oujda highway, thereby disrupting traffic and leading to the relocation of homes situated at the top of the slope.

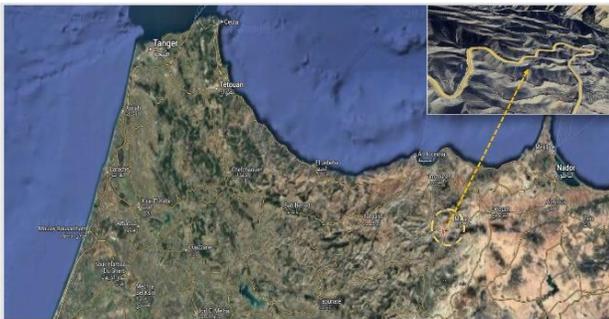
The instability sections studied are located on the Taza – Al Hoceima expressway in the Driouch province. The satellite image in Figure 4 illustrates the location of the studied unstable areas:

Fig. 4 Location of the unstable sections on the Taza-Al Hoceima expressway

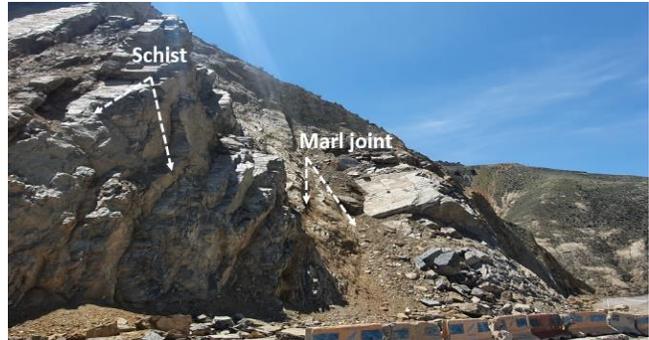
Fig. 6 Slopes dominated by schist and marly schist

In the majority of the studied areas along the road, the rock debris is mainly composed of stratified fractured schists, sometimes enriched with marly fillings. The slope geometry reveals relatively steep banks, which pose significant regional stability issues.

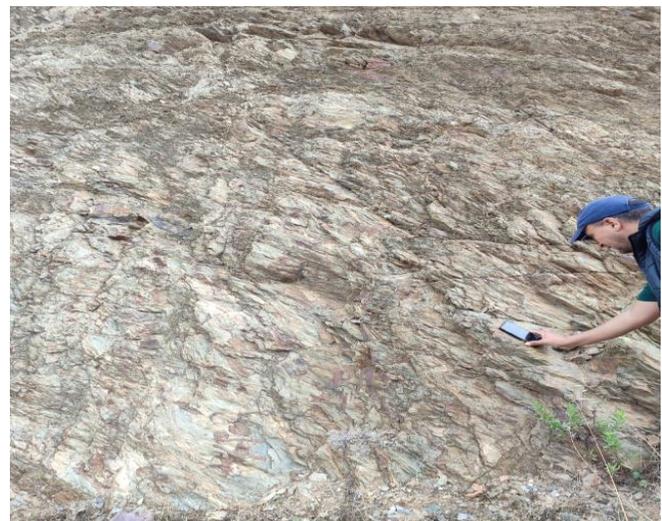
Fig. 7 Flaky structure of schists affected by an intense fracturing network

Indeed, due to their stratification and flaky structure (Figure 7), the schists exhibit a natural tendency to fracture along their bedding planes, which can weaken the overall strength of the mass. This inherent fragility increases the risk of landslides and collapses, particularly in areas where rock benches are exposed to mechanical stress or extreme weather conditions.

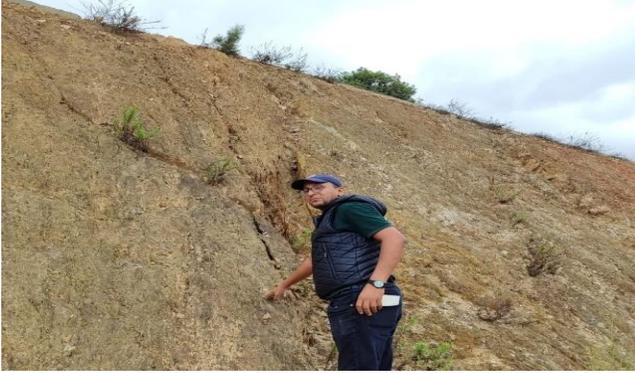
Fig. 8 Affected schist mass showing several marly joints

Furthermore, the marly-filled joints, which act as points of weakness in the rock mass, further complicate the situation, especially during bad weather when these joints tend to become saturated with water, leading to a significant reduction in cohesion among rock particles (Figure 8).

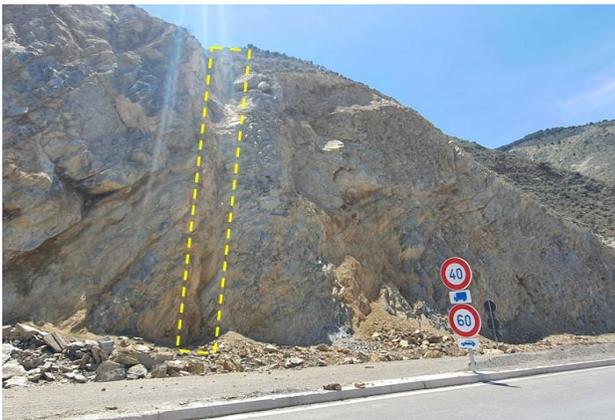
Fig. 11 Weak plane in the form of a marly joint

Several fractures and faults traverse the different layers. These fractures are sub-vertical and affect all lithological units present (shales, marl shales, and sandstones). They are more concentrated in sections S2 and S4, potentially indicating areas of greater fragility. The presence of "marl joints" represents potential weakness planes within the rock mass (Figure 11).

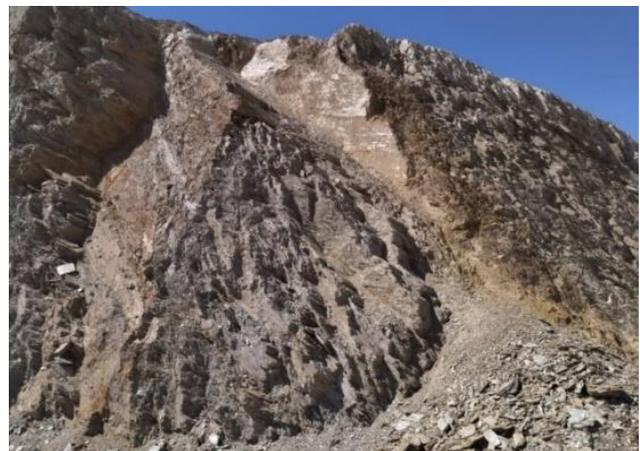
Fig. 12 Several detached blocks are observed in section 11

This type of risk has been observed in sections S1, S2, S17, and S20. Heavily inclined discontinuities (70° and 80°) are the main cause of the observed rockfalls, especially in highly weathered areas. Thus, the presence of fractures and joints in a sloped context increases this risk. It results from the presence of breccias and syndimentary faults. Hard and fractured layers have been located above loose layers in areas with steep topography and the absence of vegetation.

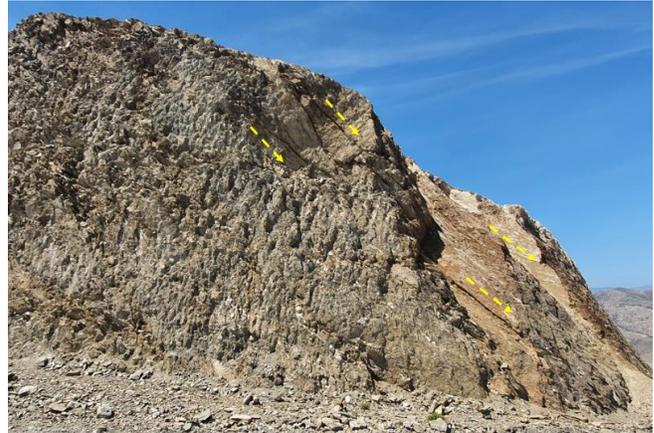
Fig. 13 Unfavorable orientation of discontinuities

The relative orientation of discontinuities may determine whether the excavation wall is stable or not (Figure 13) [15].
