Original Article

Flexural Failure of Bamboo Reinforced Concrete Beams

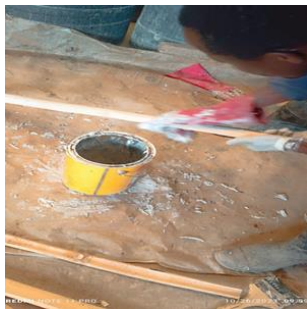
Fig. 2 Coating bamboo bars using Sikadur 32

The fine aggregates were subjected to sieving through a 4.75mm sieve, whereas the coarse aggregates were passed through a 20 mm mesh before the experimental work began. The aggregates were thoroughly washed and air dried afterwards to reduce silt content and other debris. The stirrups were also bent to the appropriate dimensions awaiting to enclose the bamboo bars. The epoxy bonding agent, Sikadur 32, was used to coat the bamboo culms in accordance with the designer's specifications. Stirring of the agent mix was done appropriately to remove any entrapped air [23].

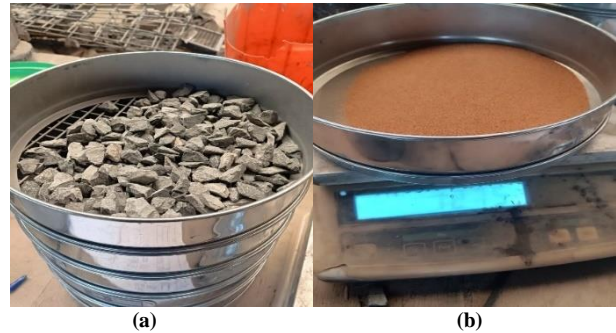
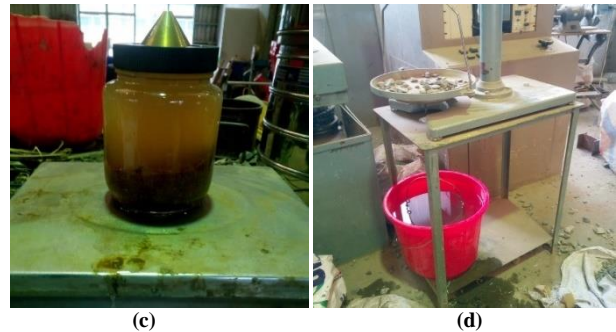
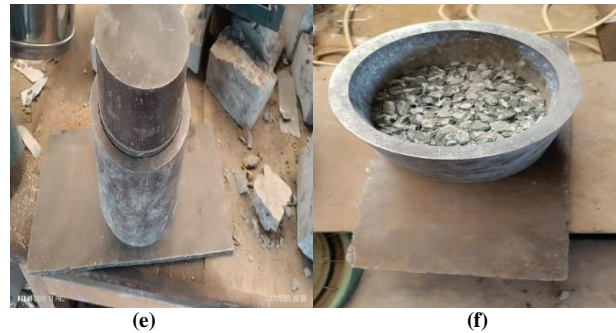
Fig. 3 Tests conducted on fine and coarse aggregates: (a) Particle size distribution of coarse aggregates, (b) Particle size distribution of fine aggregates, (c) Specific gravity of fine aggregates, (d) Specific gravity of coarse aggregates, (e) and (f) ACV setup

The strength assessment of coarse aggregates under continuous load impact occurred through the Aggregate Crushing Value (ACV) test, which followed BS 812-110 standards. The fine and coarse aggregates were analyzed for water absorption following ASTM C128 standards while their specific gravity was tested using ASTM C127. The test results contributed to concrete density determination and porosity measurement, which shaped the mix design for future performance assessment. The Aggregate Impact Value (AIV) test was done to check how tough the coarse aggregates were

when subjected to sudden impact. This helps gauge their resistance to wear and tear. The specific gravity of both coarse and fine aggregate tests followed the ASTM C127 and ASTM C128 to see how dense they were compared to water. This is important for mix design since it affects concrete's overall weight and stability. Using these results, the water absorption was calculated.

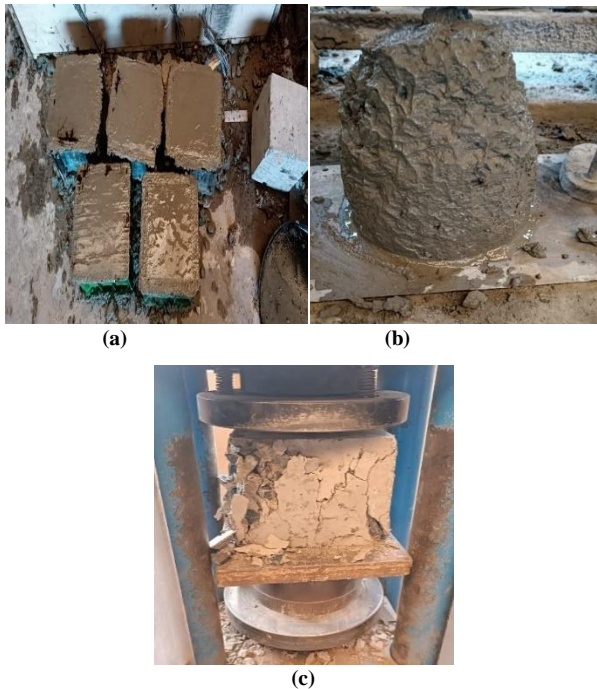
Fig. 4 Pictorial representation of: (a) Casting of cubes, (b) Slump test, and (c) Compressive strength test

The workability of the fresh concrete was obtained from the slump test following the ASTM C143, the purpose of which was to determine the right consistency for placement. The concrete was filled in a slump cone in three successive layers, and compaction was done carefully using a tamping rod in addition to each layer to remove any trapped air. Once filled, the cone was lifted, and the slump value was measured.

Cubes of dimension $100 \times 100 \times 100$ mm were subjected to compressive strength test in line with the ASTM C39 procedure. The cubes were placed in a curing tank and tested at 7 and 28 days. During testing, the cubes were placed in a Universal Testing Machine (UTM) and load was applied until failure. Additionally, a splitting tensile strength test following ASTM C496 was performed to analyse the concrete's resistance to tensile loads, and the results were recorded.

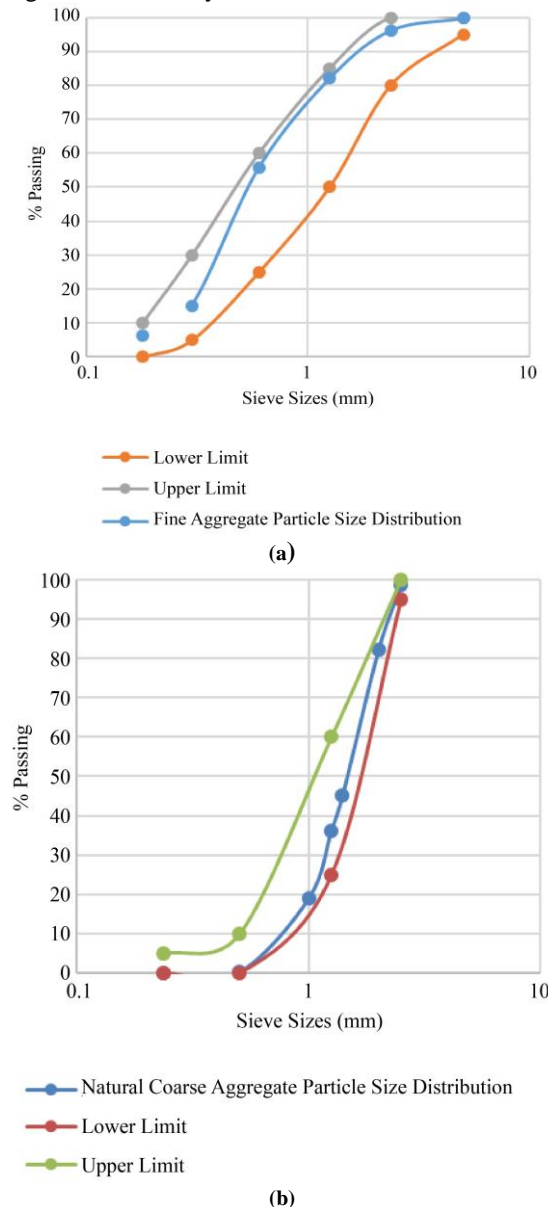
Fig. 6 Particle size distribution for, (a) Fine aggregates, and (b) Coarse aggregates

Fine and coarse aggregates underwent sieve testing according to the ASTM C136 method for analysis and yielded the following results. The test method revealed meaningful information about the size distribution and grading characteristics needed to produce a densely packed mixture. The gradation of the coarse aggregates shows an even distribution, with most particles passing the upper sieves (25 mm) and fewer in the lower sieves (2.36 mm).

This indicates a well-graded coarse aggregate that imparts higher strength to concrete. Similarly, the outcome indicates a well-graded fine aggregate that falls within the specified limits. The well-graded nature of the fine aggregates will ensure that the cement paste-to-aggregate bond is improved.

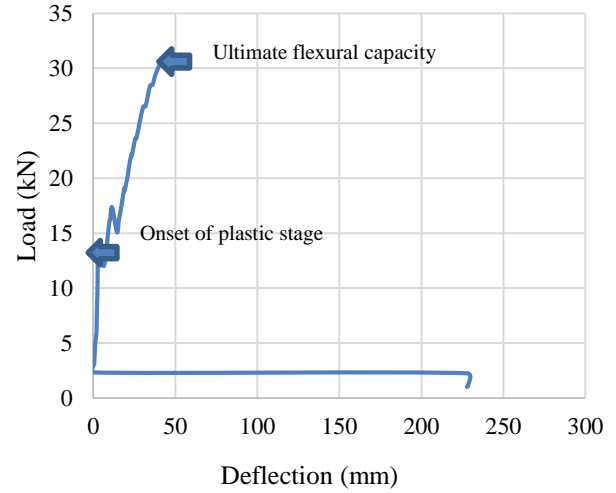
Fig. 7 Load vs deflection graph for 150 × 300 beam

The load-deflection graphs show the beam response to applied loads. The 150 × 300 mm beam displayed a clear transition from an initial linear phase, where the beam behaved elastically, to a non-linear phase. This pointed to the development of cracks and the progression into plastic deformation. The ultimate flexural capacity reached the graph's peak, beyond which the beam could no longer withstand additional loading. The 1100 × 300 × 300 mm beam displayed similar behavior, the difference being the noticeably steeper initial gradient. This implies higher stiffness because of the increased cross-sectional area. The implication is that the larger beam will experience less deflection when you apply the same load, supporting the idea that depth plays a crucial role in flexural performance. As seen, deflection increased rapidly beyond the elastic limit, meaning that whereas the bamboo reinforcement accounts for some capacity of ductile behavior, the flexural strength of the beam is what enabled it to resist failure. The cracks present in the tension zone weaken the beam over time, leading to failure as the load exceeds the resistance capacity [25].

- The load-deflection curves showed that the 1100 × 300 × 300 mm beam had higher stiffness than the 1100 × 150 × 300 mm beam, experiencing lower deflection for the same applied load. However, both beams exhibited similar non-linear behavior as cracks developed, indicating the onset of failure.

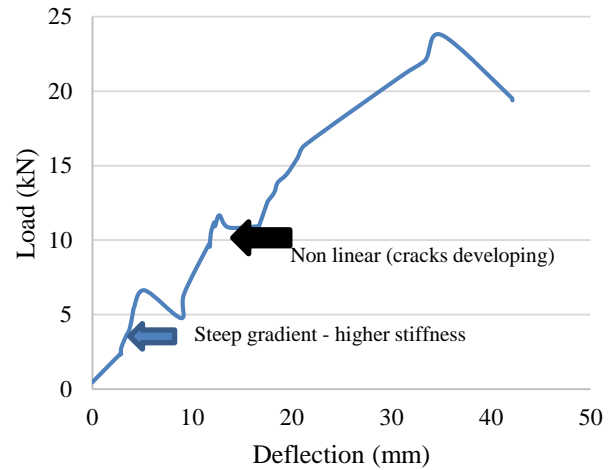
Fig. 9 Load vs deflection graph for 300 × 300 beam

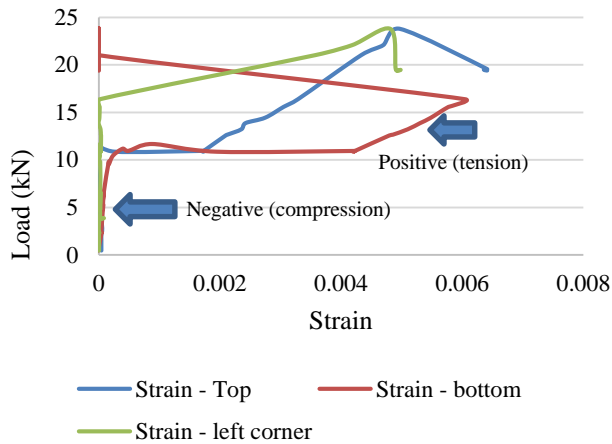
Fig. 10 Load vs strain graph for 300 × 300 beam

- Strain analysis confirmed that compression occurred at the top while tension built up at the bottom, causing crack formation. The top strain had a negative value range, while the bottom strain was all positive, with strain values ranging from -0.005 to 0.015 for the 1100 × 150 × 300 mm beam and 0 to 0.008 for the 1100 × 300 × 300 mm beam.
