Original Article

# Weathering-Controlled Transition of Slope Failure Mechanisms and Applicability of Kinematic Models in Silurian Schists (Rif, Northern Morocco)

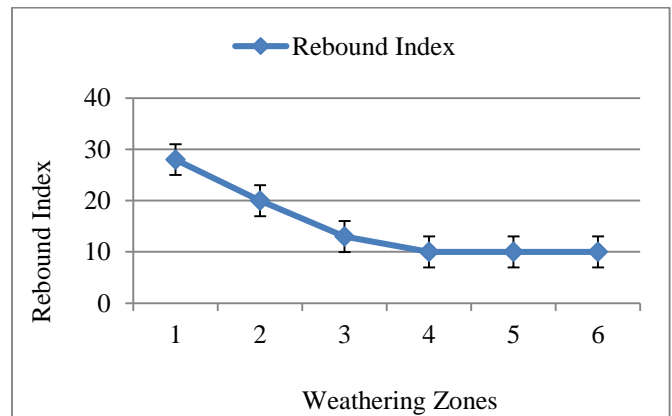
Fig. 4 Schmidt hammer rebound index variation across the weathering zones

The major trend of the rebound index evolution begins with a gradual decrease in weathering zones 1 to 3, due to the progressive degradation of the rock matrix. This indicates an increasing weakening of the rock structure due to mineral weathering, microfracturing, and increased porosity. In these zones, the average rebound values remain within the Schmidt hammer range but show increasing variability as weathering progresses.

A marked increase in the dispersion of rebound indices is observed in weathering zone 3. This increased variability is representative of the mechanical heterogeneity that characterizes transitional weathering domains, in which partially intact rock structures coexist with increasingly degraded matrix materials. Such dispersion is therefore considered to reflect transitional behavior in the weathering process [27].

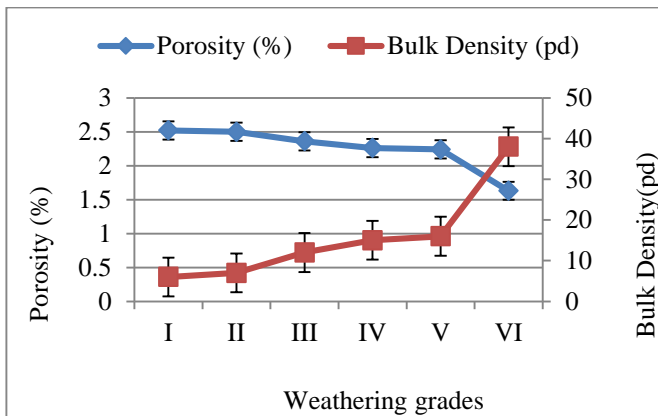
Fig. 5 Variation of porosity and bulk density across the weathering grades

Physical properties show systematic trends with increasing weathering grade. Porosity increases while bulk density decreases, reflecting progressive material loosening and structural breakdown. These trends progress gradually through weathering grades I to IV before being marked by a

break point observed in the transition between grades V and VI, where the porosity reaches its highest values of 38%, and the bulk density drops abruptly, marking a mechanical and structural threshold in the weathering profile.

Grade IV shows marked variation in bulk density and total porosity, as indicated by a relatively high standard deviation. This variability probably stems from the heterogeneous development of fracture connectivity and mineral alteration at this intermediate stage of weathering. Although the samples are classified at the same grade, the degraded internal structure appears uneven, reflecting variable changes in porosity.

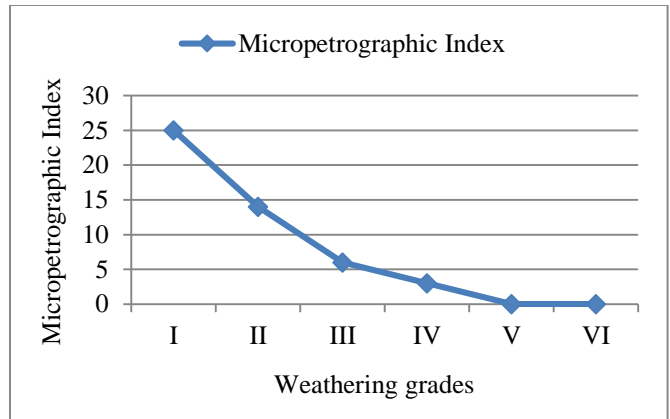
Fig. 6 Micropetrographic index changes across weathering grades

The same trend is observed in petrographic degradation. The micropetrographic index decreases with increasing weathering, reflecting the progression of mineralogical alteration and texture disorganization. The index declines significantly from grade I to III, then gradually continues downwards through grade IV and V, finally reaching zero at grade VI — residual soil type in which the original rock fabric has been destroyed.

However, the standard deviation reveals that dispersion is significantly higher in grade II than in other grades. This dispersion likely reflects the heterogeneous onset of micro-alteration processes, which are not yet fully pronounced at the macroscopic scale. Despite macroscopic classification of samples into the same weathering grade, thin-section observations reveal varying degrees of mineral weathering and microfracturing, resulting in greater intra-grade variability.

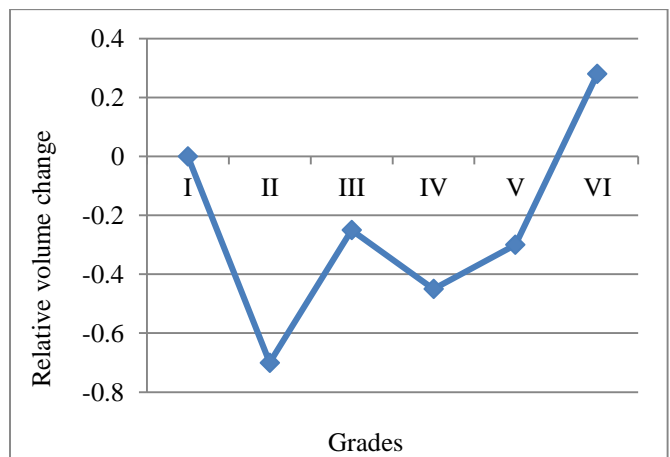
Fig. 7 The Relative volume changes across weathering grades, reported to the fresh rock

Geochemical analyses show significant mass and volume changes as weathering progresses. The relative volume change is negative for all degrees of weathering except degree IV, indicating a loss of solid mass in the rock caused by the dissolution and leaching of soluble mineral phases; consequently, the volume gains by minerals neof ormation and hydration in the resulting soil are represented by degree IV.

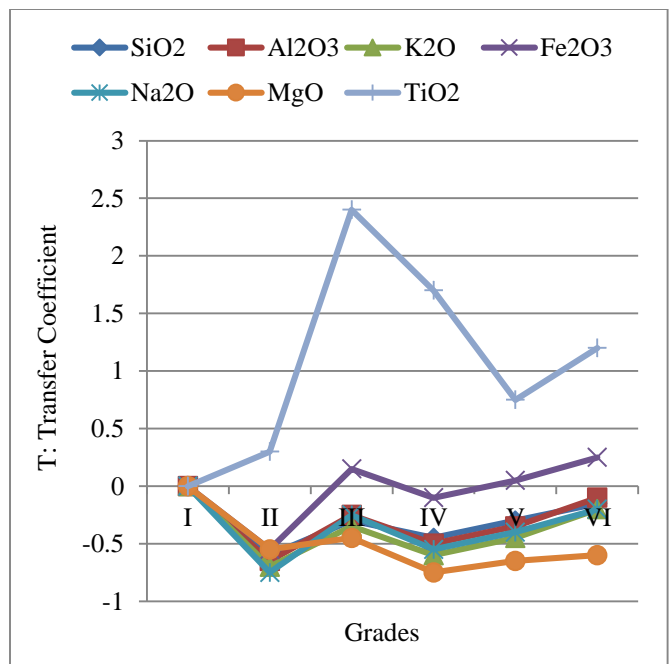
Fig. 8 The mass transfer function changes across weathering grades, reported to the fresh rock

Mass transfer calculations show deep leaching of mobile elements (e.g., Potassium K and Silicon Si) with residual enrichment of immobile elements (e.g., iron Fe and Aluminum Al).

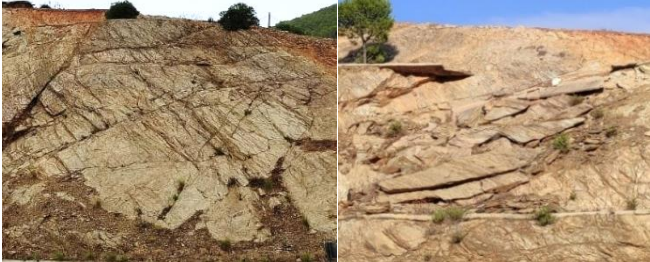
**Table 1. Results of the kinematic analysis for the three slope sections, including the percentage of discontinuity planes favoring planar sliding, the percentage of plane intersections favoring wedge sliding, and the types of instabilities documented during field observations**

Slope	Dip/Dip Direction	Planar Sliding	Wedge Sliding	Observed Instability
A	56°/275°	47%	56%

B	59°/303°	16%	58%	Minor block detachments
C	56°/ 355°	1.5%	35%

Slope A is highly admissible in terms of kinematics for both planar and wedge sliding, which is compatible with the observed disorder on this slope. Although slope B shows low admissibility for planar sliding and high admissibility for wedge sliding, field observations show that this slope behaves as a globally stable slope, with only a few block detachments. Slope C displays very low admissibility for planar sliding and moderate admissibility for wedge sliding, whereas field observations show rotational sliding.

The observed differences between kinematic admissibility and observed failure reveal that geometric compatibility is a necessary condition for structure-controlled failure, but that it alone does not determine its occurrence.
