Understanding the Types and Characteristics of Landslides in Sri Lanka

Vasanthakumary Selvanayagam

Department of Geography, Faculty of Arts and Culture
Eastern University, Sri Lanka

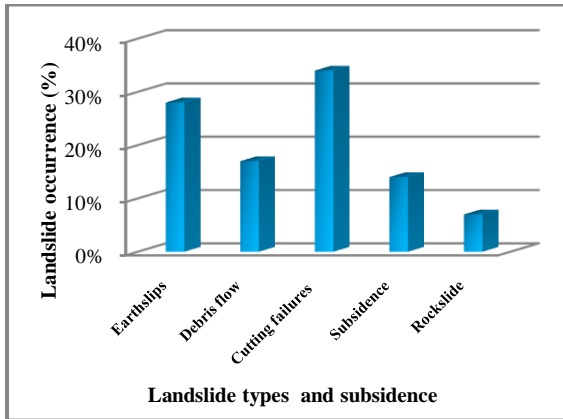
Fig 01: Occurrences of landslides by types and subsidence in the study area (based on the past landslide records and the field investigation)

Based on the occurrences, cuttings failures were high in terms of frequency following earth slips. Among other types of landslides, rockslides were very low in frequency. Debris flow and subsidence events were occurred at modest level. Soil creep is a widespread phenomenon while rock fall events are infrequent. However, debris flows carry more risk than other types.

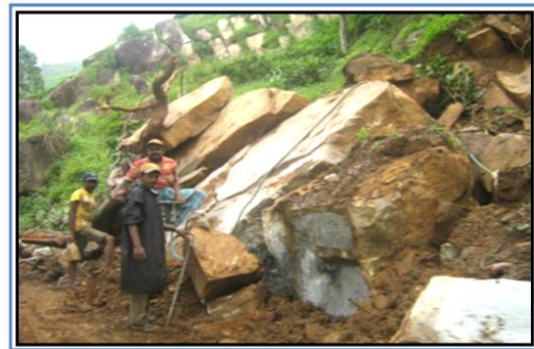
Plate 03: Rockslide in Pitakande (Field survey)

In terms of spatial distribution, small scale rock slides have occurred in Bambaragala, Pitakande, Welangahawatta and Bodhikotuwa division and such events have only brought the disturbance to the transportation and minor damages to the houses. The Plate 03 shows the rock slide occurred in 2012 which had resulted disturbance to the transportation along Pitakande – Kandenuwara Road in Punchyselwakanda division. Moreover, risk of rock fall is high in the Kotagahawella area in Welangahawatta division. When rock fragments fall down, the people residing in the lower slope area are facing the negative impacts for last few years.

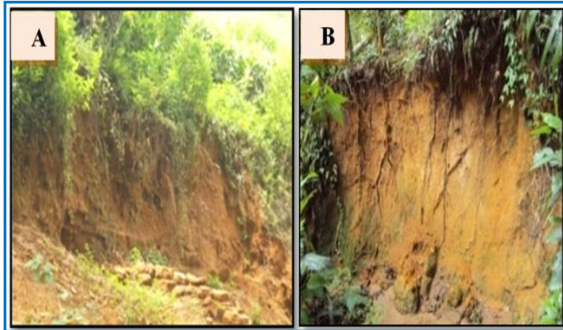
Plate 04: Cutting failures. (A) Pitakande. (B) Madakumbura, (Field survey)

along the roads such as Punchyselwakanda - Thambalagala, Rattota - Riverston, and Madakumbura. Hence, Grama Niladari divisions such as Bodhikotuwa, Mousagolla, Welangahawatta and Bambarakiriella divisions are also exposed to similar hazard. In terms of frequency, cutting failures have been reported relatively high in Bodhikotuwa following by Madakumbura division. The Plate 04 below shows some of the cutting failures occurred in the study area.

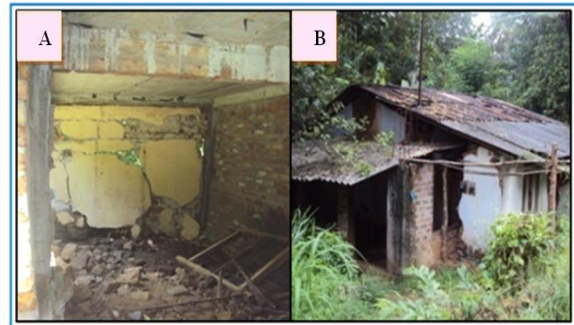
Plate 06: Houses damaged by subsidence in Mousagolla and Bodhikotuwa division (Field survey)

Subsidence was another important hazard associated with landslide occurrences in the study area. The sudden collapse of the land surface into the subsurface has increased the landslide threat in this area. The study revealed both Bodhikotuwa and Mousagolla divisions are more vulnerable to subsidence hazard. Though it is quite difficult to recognize prior to the event, it brings severe negative impacts. Head of the NBRO district office of Matale states that “the land subsidence investigations carried out following the unusual observations in this area clearly revealed that the cavities prevail underneath the earth surface was the primary cause of land subsidence”. The situation has brought a higher level of risk to people and settlements in the study area. The damages to settlements caused by land subsidence are shown below (Plate 06).

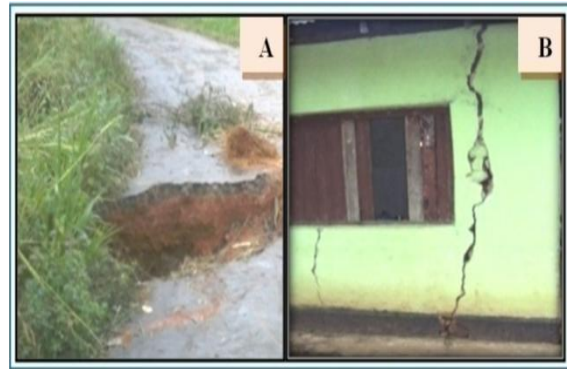
Plate 07: Evidences of soil creep (Kandenuwara–Rattota & SVK division). (Field survey).

Moreover, tension cracks which appeared at various times on the slopes of the Bambaragala, Thambalagala, and Pitakande divisions, and along the roads in Kandenuwara–Rattota were also considered as an indication of the slope instability and potential for future slumping in this region. Thus, the development of tension cracks in conjunction with the slope instability demands the remedial works to inhibit landslide processes. The Plate 07 below indicates the cracks appeared in the road and line rooms in SVK division.

Similar to the tension cracks, cracks which are developed in the houses also another important indication of slope instability in this region. Such cracks were a perceptible phenomenon in the floors, concrete roofs and walls of the houses and exterior area. The details of cracks shown in Fig 02 reveals that most of the houses have cracks in the walls and floors, however, number of cracks in the walls are relatively higher than the cracks in the floor. Fewer cracks identified both at concrete roofs and fences. Similarly, vertical cracks are relatively higher than horizontal cracks.

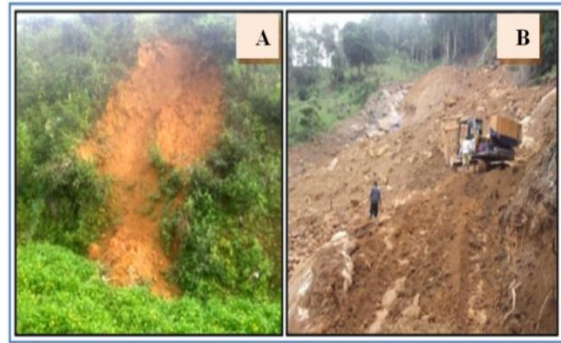
Plate 08: Small and large scale landslides. (A)Thambalagala. (B) Madakumbura. (Office of Grama Niladari and Field survey).
