# Analysis and Assessment of Land-use and Land cover and Water Quality of the Chikkamadhure Lake and Obanaikanahalli Lake using Remote Sensing and GIS, Karnataka, India

Sadashiv Machappanavar<sup>1</sup>, P. J. Malini<sup>2</sup>, K.C. Gouda<sup>3</sup>, K.V. Ramesh<sup>4</sup>

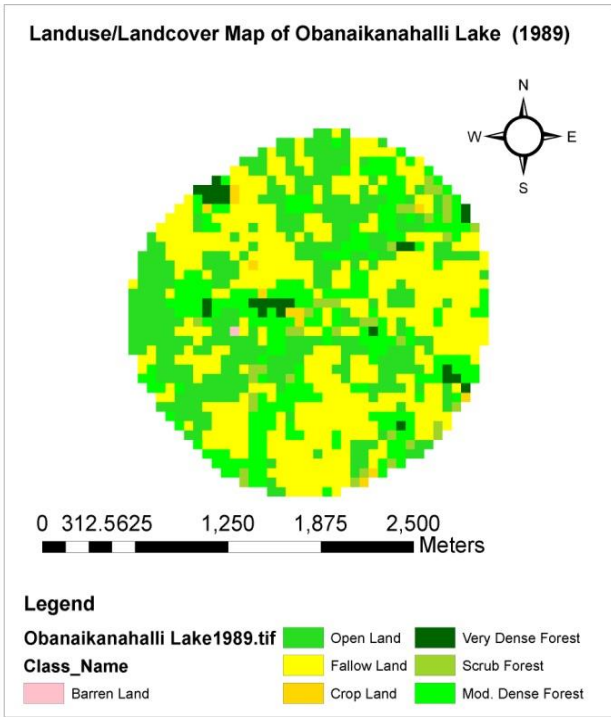
Fig. 6 LULC map of Obanaikanahalli Lake (1989)

LULC PARAMETERS	1989	1999	2009	2021
Open Land	125.64	133.83	83.61	351.63
Fallow Land	178.2	132.57	92.88	245.25
Crop Land	4.32	4.14	21.15	133.38
Very Dense Forest	9.72	32.13	21.15	197.19
Scrub Forest	14.04	71.19	133.92	376.65
Mod. Dense Forest	87.84	34.65	39.78	185.94
Barren Land	0.36	6.21	13.68	98.01
Built-up Land		0.45	3.42	52.74
Water bodies		4.14	9.72	36.9

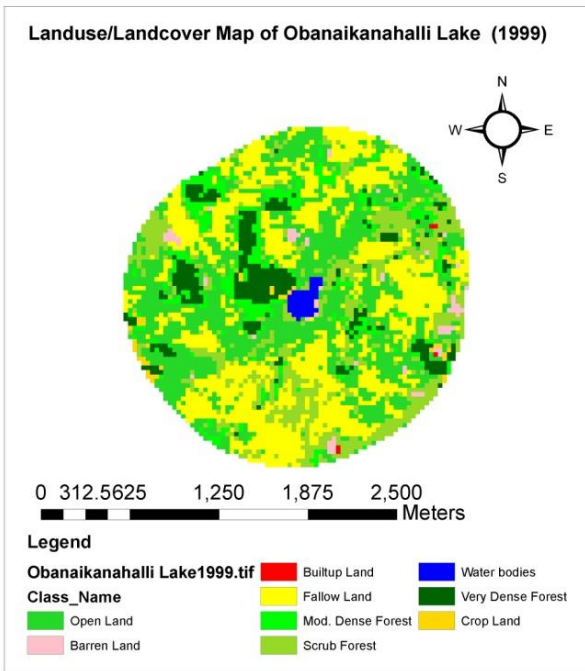
Fig. 7 LULC map of Obanaikanahalli Lake (1999)

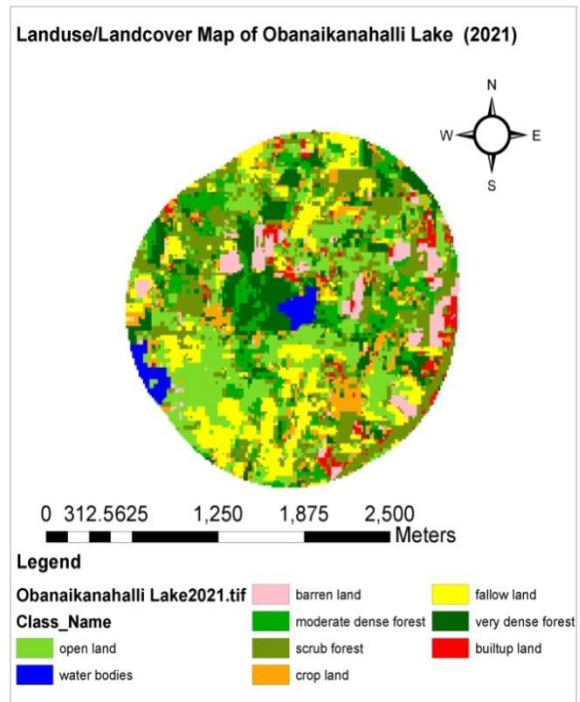
Fig. 9 LULC map of Obanaikanahalli Lake (2021)
