Accessibility for Disabled Individuals at Shopping Centers in Surakarta

Abstract

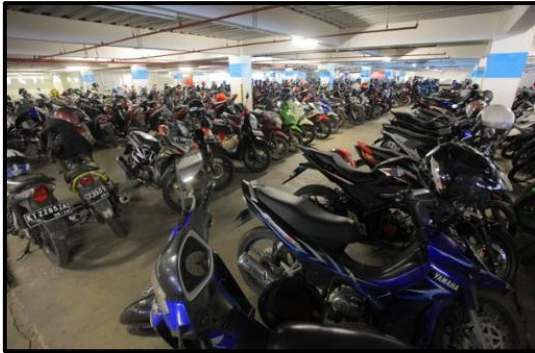
The first aspect observed was the parking area. Parking spaces in shopping centers in both SS, SGM and HM have not provided individual disabled parking areas. According to Ministerial Regulation no. 30 of 2006, at 1-25 the number of available parking areas, there is at least 1 accessible parking area for disabled individuals.

Picture 1. Solo Square Parking Area

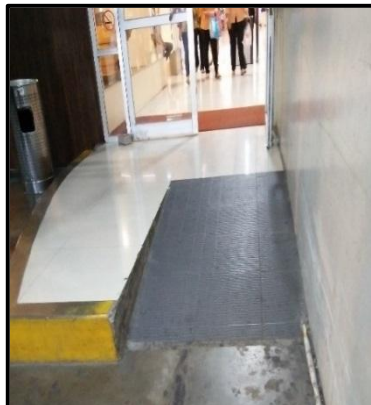
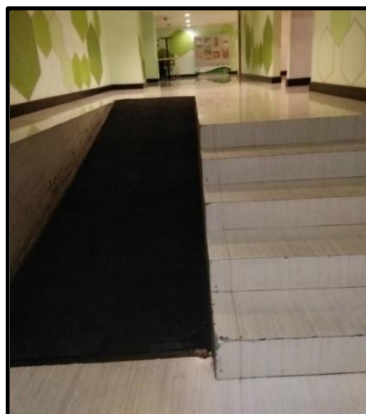
The slope of the *ramp* in the third shopping centers was not yet qualified. One shopping center does not have a *ramp* in the room. Meanwhile, two of which exceed the maximum, examples 9° and 30°.

Picture 2.1. Ramp Indoors

Picture 2.2. Ramp Indoors

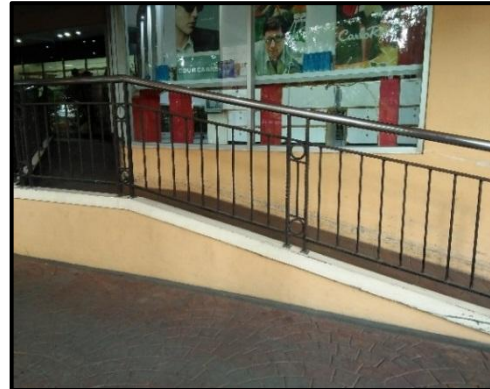
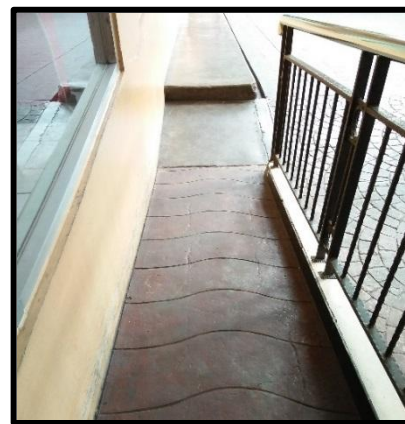
The slope of the *ramp* in the third shopping center, one of which has been qualified, example a

maximum of 6°. However, two shopping centers do not have an outdoor ramp.

Picture 3.1 Ramp Outdoors

Picture 3.2 Ramp Outdoors

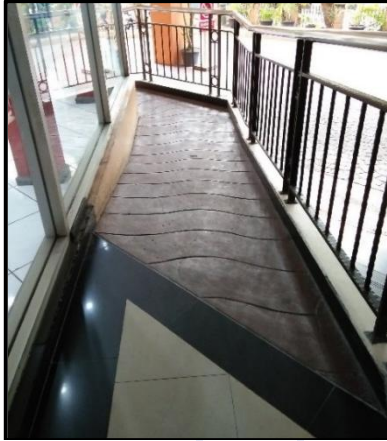
Prefix and suffix *ramp* one shopping center had been qualified, that was textured. However, two other shopping centers have not been accessible.

Picture 4. Prefix Textured Ramp

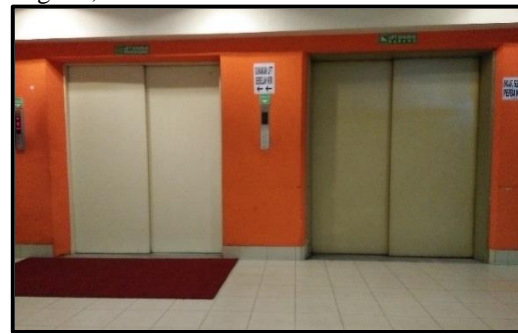
The width of the waiting room enter the elevator of the three shopping centers have been eligible, which is at least 185cm

Picture 5. Waiting Room Entering The Elevator

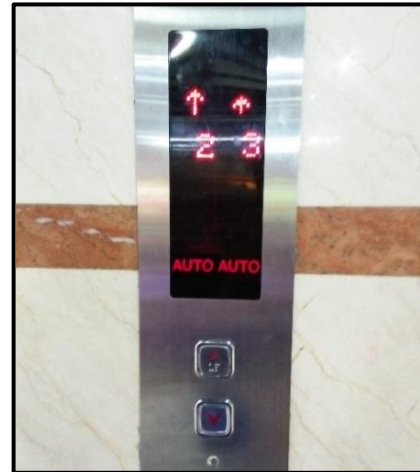
The buttons and display screens of all three shopping centers are eligible, which are easy to see and reach.

Picture 6. Screen Display

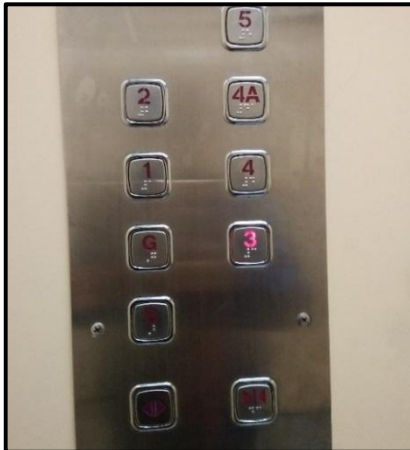
Panel one shopping center had been qualified, which was equipped with Braille. However, both shopping centers were not equipped with braille.

Picture 7. Braille Brace Elevator Button

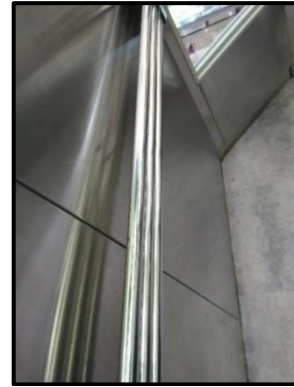
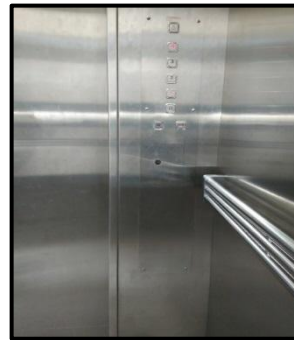
One of the shopping centers had been qualified because it had a vine grip on either side of the elevator. However, the other two shopping centers did not have a velocity held on both sides.

Picture 8.1 The Creeper Inside the Elevator

Picture 8.2 Handles In The Elevator

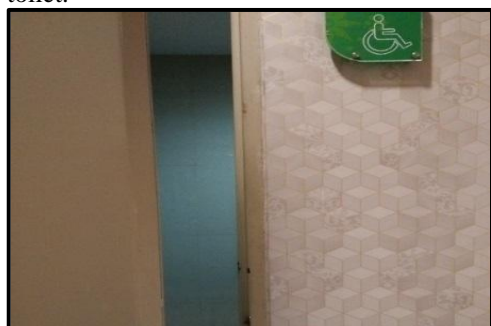
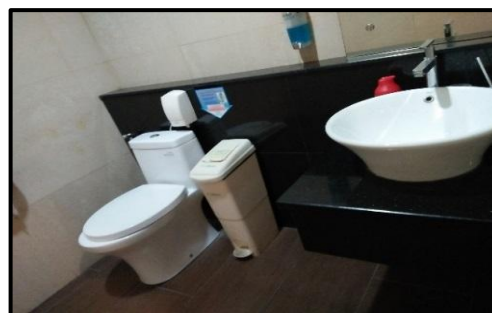
One shopping center had a disability symbol on the outside. In addition, there was also a room for changing diapers for infants so that it had accessible qualifications. However, the other two shopping centers were not eligible, as there was no symbol of people with disabilities on the outside of the toilet.

Picture 9.1 Disabled Person Symbol

Picture 9.2 Disabled Person Symbol

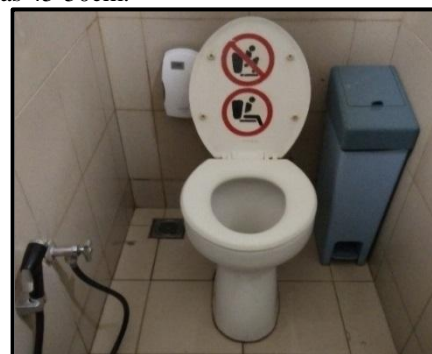
Elevation of the toilet seat of those three shopping centers had been eligible, which was as high as 45-50cm.

Picture 10. High Closet

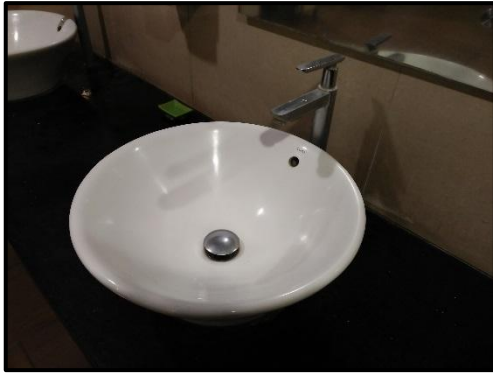
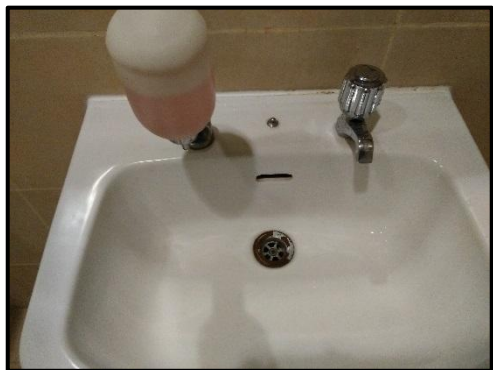
One of the shopping centers has used a lever system on the sink faucet so it qualifies. However, the two shopping centers were not eligible for using a turntable system and a tap system on the sink faucet.

Picture 11.1 Washbasin Lever

Picture 11.2 Welding Fans

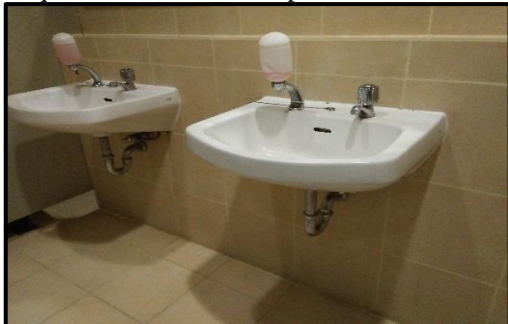
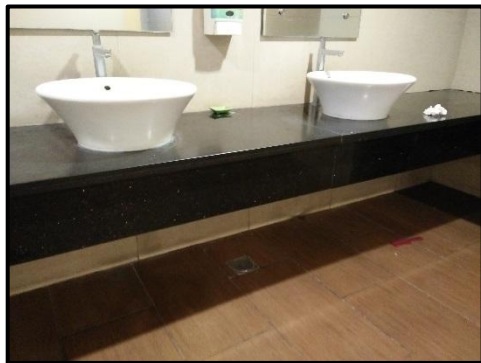
The third sink of the shopping center had been qualified, which had a space below it.

Picture 12.1 Wigroom Under The Sink

Picture 12.2 Wigroom Under The Sink

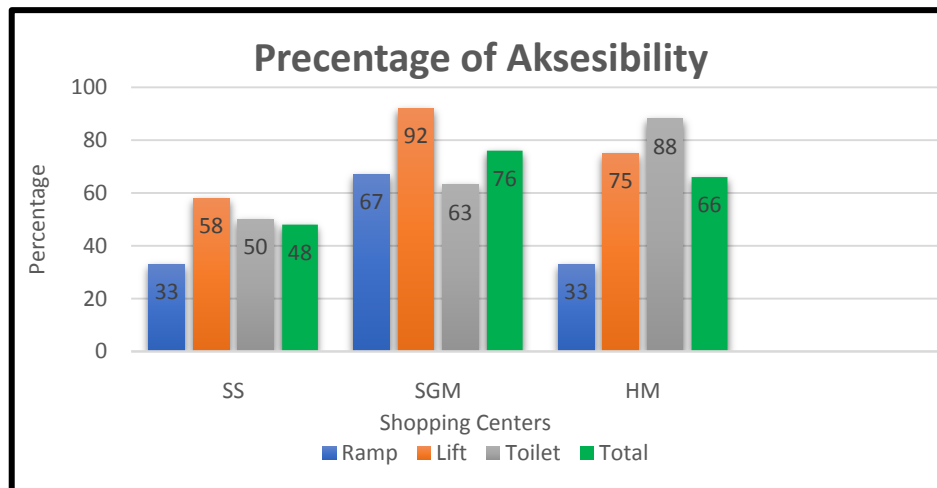
Based on the table above, it can be seen that overall percentages of the level of accessibility to the shopping centers in Surakarta were between 48%-76% in the number of indicators met 14-22 of 29 accessible indicators. Access level of the SS shopping center was 48% with 14 accessible indicators; SGM was 76% with 22 accessible indicators; and the last was HM, an accessible level of 66% with 19 accessible indicators.

The percentage of each shopping center is presented in the following graph.

SGM and HM had an average accessibility rate of over 50%, while the SS still did not meet the average, as it only met 48% of the accessibility level. Therefore, it is necessary to improve gradually on the aspects of accessibility as a whole and in all public facilities in Surakarta, not just at the shopping center.
