New Design and Idea for Investigating the Defect Inside the Gearbox by Experimental and Simulation Results

Keywords: Gearbox, Axle Shaft Duster, Logan Automotive, Sensor, Simulation

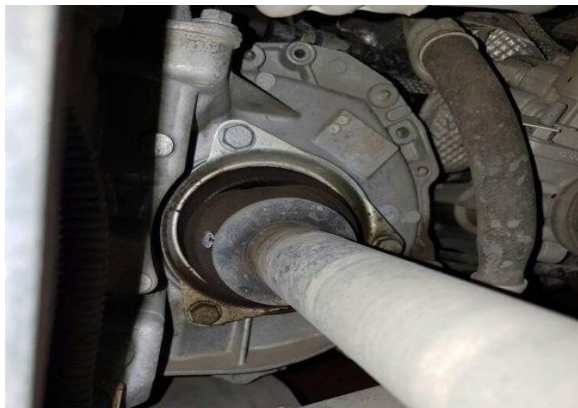
When the axle shaft duster of the Logan automotive is t, the Vascazin gearbox comes out of the duster, and even this leak will come out of the roller bearing around the duster. When the Vascazin comes out of the duster, the gears work dry, and

no cooling is done, and the four or five gears start to make noise, and eventually, the automotive gearbox burns out. Figure 2 shows the rupture of the axle shaft duster, and Figure 3 shows the discharge of vascazin as described.

Fig 2. Rupture of the axle shaft duster

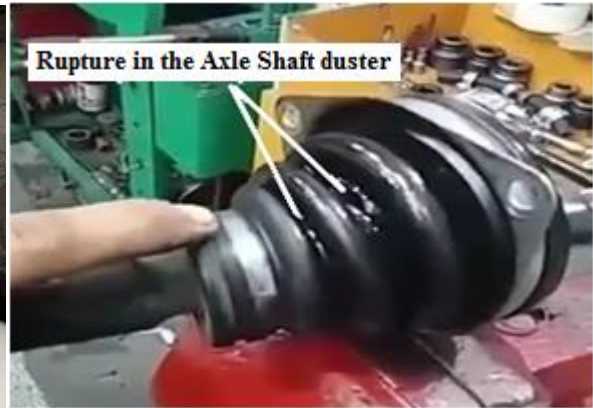
Fig 3. Discharge of vascazin

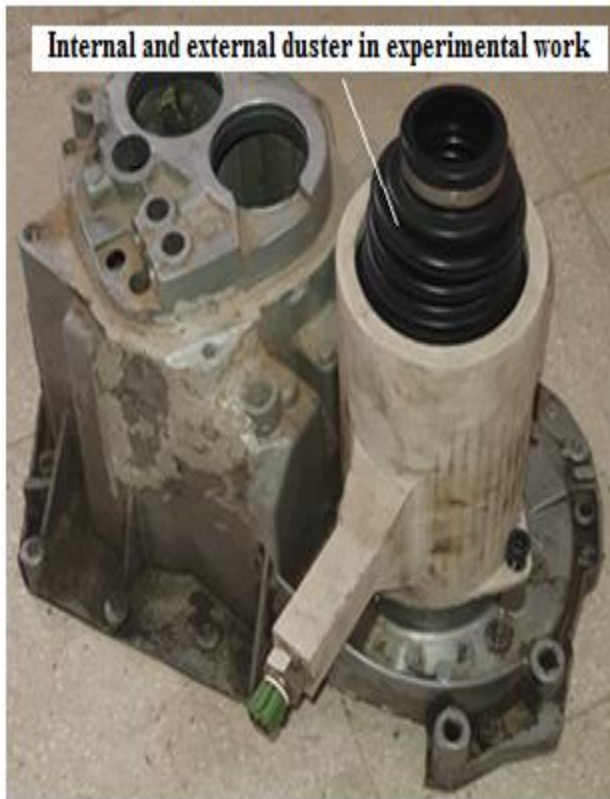
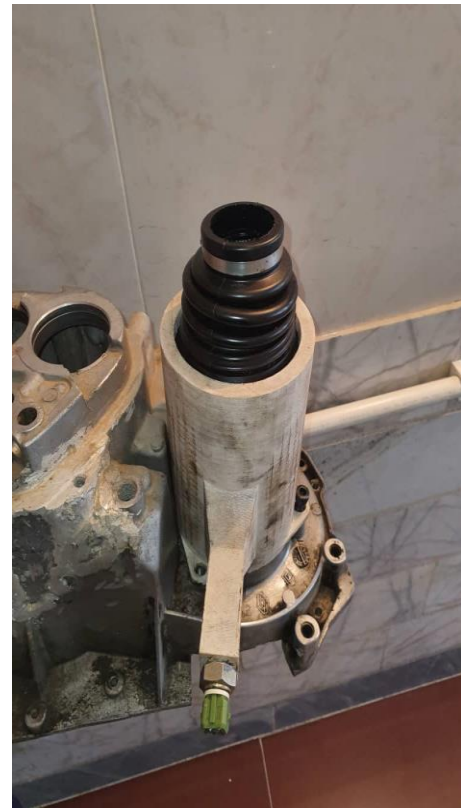
In this design, the chamber is installed around the duster, and there is no need to lower the gearbox, and the chamber will be installed on the work, which is one of the advantages of this design. All internal and external machines, whether advanced or non-advanced, all tearing the axle shaft duster and cause the axle shaft to malfunction. This housing can be installed on all machines to protect against duster and

damage to the axle shaft and does not allow the sharp object to tear it. For the best location for the sensor, it can be installed where there is oil. This enclosure and sensor are designed for the Logan automotive and can be used for automotive with similar problems. Figures 4 and 5 show the experimental work and design of the enclosure.

Fig 4. Sample of experimental work done **Fig 5. Another angle of the experimental work sample**

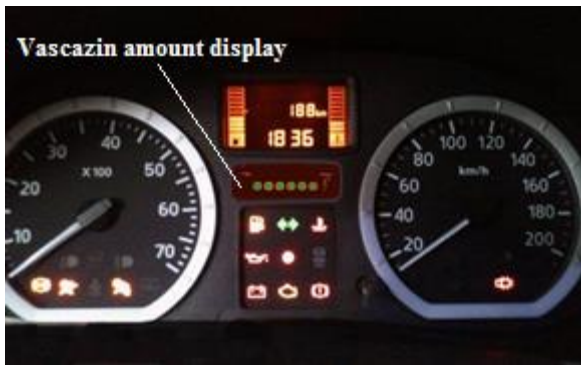
The automotive mileage screen will turn green, which you can see in Figure 7. If the amount of Vascazin is moderate, the screen on the automotive odometer will turn yellow, as shown in Figure 8. If the amount of vascazin is low or discharged, the screen on the automotive odometer will turn red, as shown in Figure 9. According to this design, when the Vascazin is empty or low and turns red, the automotive power relay shuts off before reaching this alarming stage, and the automotive shuts down. As you can see in Figure 6 and the circuit design, the circuit breaker relay is installed inside the circuit. It should be noted that this issue was used in the initial design, but when the sensor is installed on the automotive, this switch relay is installed in the path of the automotive coil or automotive input power.

Vascazin amount display

Fig 7. Vascazin display on the kilometer screen
(green indicates full Vascazin)

The detector system of the logan automotive and the Megane manual gearbox with an efficient idea alert the driver to the Vascazin leak at a dangerous time, which is fully displayed by the automotive odometer display in Figure 7. With the implementation of this plan, the damages caused by the gearbox will be completely prevented. One of the important advantages of this design is that to install this innovative part, there is no need for any changes in the automotive gearbox and gearbox, And it is installed separately on the automotive.

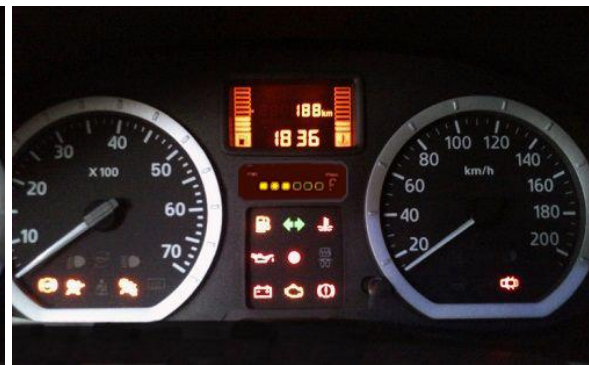
Fig 8. Vascazin display per kilometer
(yellow indicates average Vascazin size)

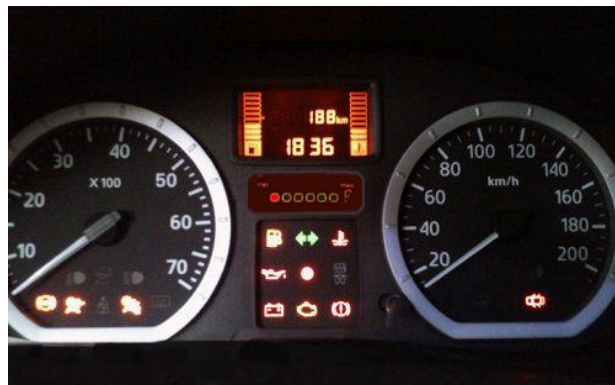
Fig 9. Vascazin display on the odometer (red indicates Vascazin is too low)

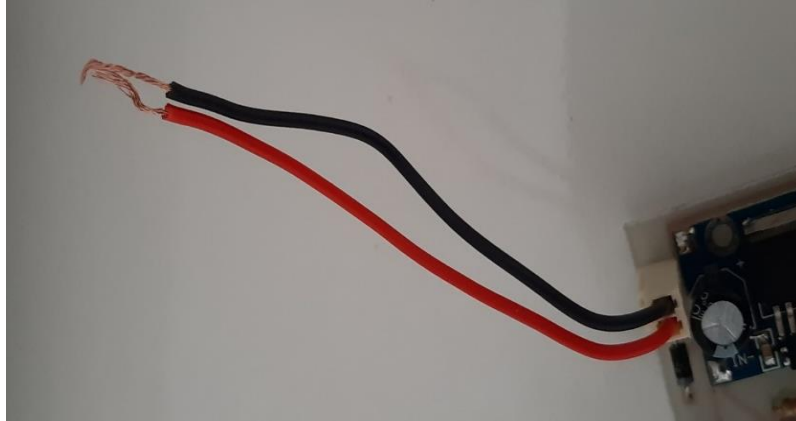
In Figure 10, you see two strands of wire, one positive and the other negative, on the circuit. The red wire is connected to the negative part of the battery or automotive body. The black wire is connected to one of the positive wires of the switch. When the sensor is activated, and the amount of

vascazin is reduced or discharged, and before the screen turns red, the automotive power relay shuts down, and the automotive turns off.

Fig 10. Power switch relay wire in electronic board
