Original Article

# Structural Condition Assessment and Strengthening of the Reinforced Concrete Arch Bridge

**Abstract** - This paper presents the results of an advanced inspection, structural assessment, and development of rehabilitation and strengthening strategies for Concrete Bridge No. 44, located on National Road N2, Prishtina - Blacë. The primary objective of this study is to identify effective methods for restoring load-bearing capacity and improving the operational safety of the bridge, in compliance with contemporary design standards as prescribed by the Eurocodes, considering the current degradation state of its structural elements and the critical importance of this infrastructure within the national road network. The assessment methodology involved systematic visual inspections, non-destructive testing, and numerically modeled structural analyses to evaluate the existing performance of the main load-bearing beams, columns, and other key components. Based on the collected data, modular and phased intervention proposals have been developed, allowing for the prioritized implementation of repair measures according to the severity of identified deficiencies and the functi

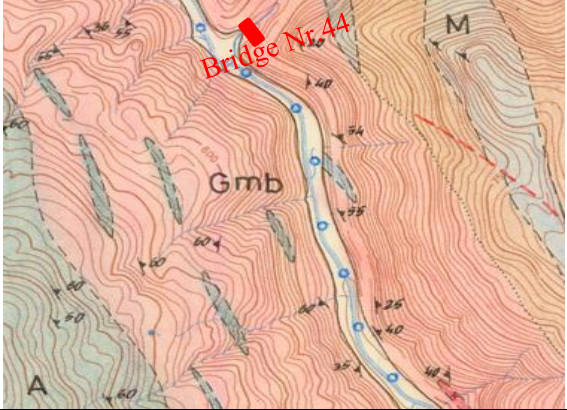
| <b>Geology</b><br><b>Paleozoic</b><br><b>(source:</b><br><b>geological map</b><br><b>1:25 000,</b><br><b>Kaçanik sheet)</b> | <b>Description</b><br><br><div style="display: flex; align-items: center;"> <div style="width: 20px; height: 10px; background-color: #f4a460; margin-right: 5px;"></div> Gmb Gneiss; </div> <div style="display: flex; align-items: center;"> <div style="width: 20px; height: 10px; background-color: #4682b4; margin-right: 5px;"></div> A Amphibolite, amphibolite </div> <div style="display: flex; align-items: center;"> <div style="width: 20px; height: 10px; background-color: #4682b4; margin-right: 5px;"></div> schist; </div> <div style="display: flex; align-items: center;"> <div style="width: 20px; height: 10px; background-color: #4682b4; margin-right: 5px;"></div> M Marble, calcschist; </div> | |
