Experimental Investigations on Properties of Special Repair Mortar for Stone Masonry Dam

U.S. Vidyarthi¹, Nisheeth Agnihotri², Ravi Agarwal³

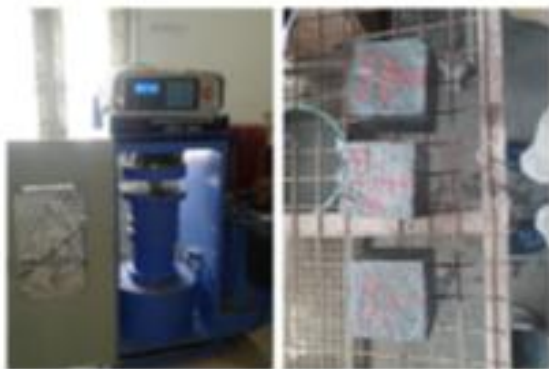
Fig.2 Compressive Strength Test

compressive strength cannot be determined due to the insufficient specimen size of the placed mortar. The mortar was prepared as per the mix proportions prescribed, and cube molds of size 70.6 mm were cast using the mortar. Curing and Compressive Strength testing of cubes were carried out as per IS 4031: Part 6.

Based on the laboratory investigation, results obtained for CT-based mortar are presented in Table 1. The results are indicative of high compressive strength, and lower abrasion depth. Moreover, the chloride ion permeability results are also indicative that the mortar is capable enough to control the ingress of chloride ions and other harmful substances. The bond strength test of repair mortar is of paramount importance due to the fact that by using priming agent resulting in good bond strength may result in lesser chances of peeling of pointing material. In the present study, a two-component priming agent was used to apply a priming coat. Due to the exposure condition, the mortar should be sufficient enough to bear the tensile stresses developed resultantly. Therefore, the split tensile test or direct tensile test of the material may carry out. The test

Laboratory Investigations	Results
Compressive Strength 28 days (N/mm ²)	69.35
Bond Strength as per Slant Shear Test ASTM C882 (N/mm ²)	11.70
Split Tensile Strength (N/mm ²) as per ASTM C496	5.77
RCPT (Coulombs) as per ASTM C1202	381
Abrasion Depth (mm) as per ASTM C1138	1.29

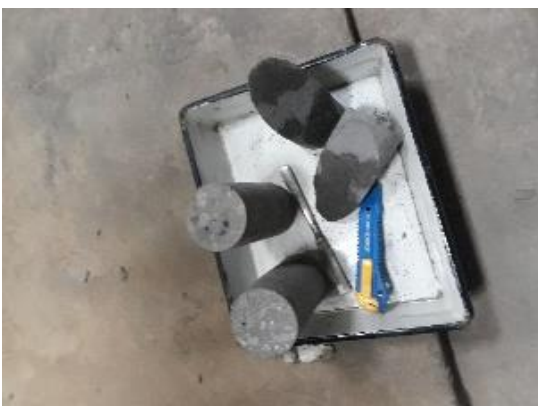
A Slant Shear test with primer at the interface was conducted to find the shear strength of CT-based mortar. It is determined by using the epoxy system to bond together two equal sections of a 3 by 6-in. [75 by

Fig.1 Slant Shear test samples

150-mm] Portland-cement mortar/concrete cylinder, each section of which has a diagonally cast bonding area at a 30° angle from vertical. After suitable curing of the bonding agent, the test is performed by determining the compressive strength of the composite cylinder. This test was carried out as per ASTM C 882.

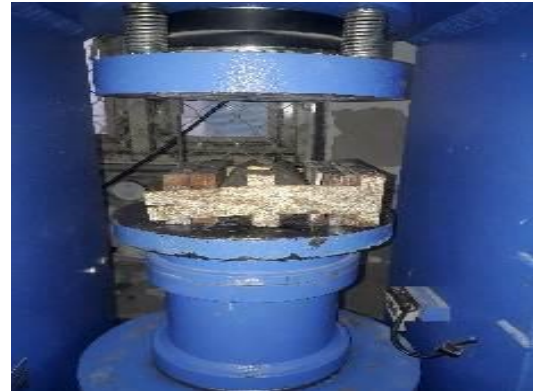
This test was conducted in accordance with ASTM C496, and three test specimens were examined by diametric compressive load along their length. Due

Fig.3 Split Tensile Strength Test Assembly

to the loading, tensile stresses were induced on the plane containing the applied load. The area under load is in a state of triaxle compression, and by this way, much higher compressive stresses than uniaxial compressive tests have resulted.

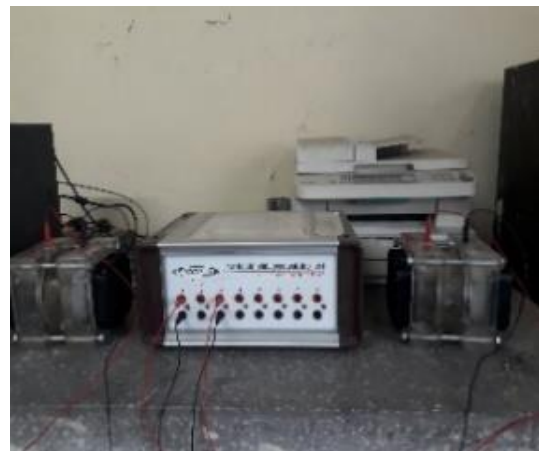
The RCPT was conducted to evaluate the chloride ion ingress through the mortar. Cylindrical specimens were cast of size 100 mm dia and 50 mm thickness and cured for 28 days. After Conditioning

Fig.4 Rapid Chloride Permeability Test

These specimens were tested in a test setup that consists of a NaCl reservoir, NaOH reservoir, and microprocessor unit. The charge passed through each specimen has been measured in coulombs. This test was conducted in accordance with ASTM C 1202.

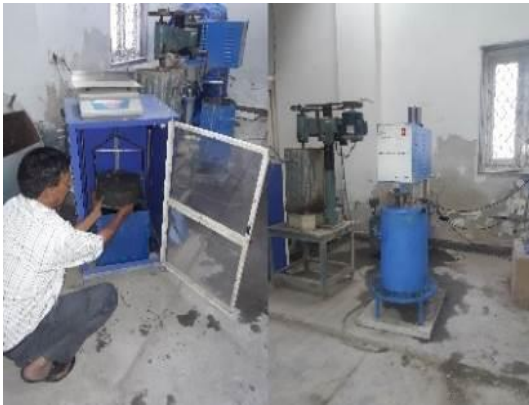
This test method is intended to qualitatively simulate the behavior of swirling water containing suspended and transported solid objects that produce abrasion of concrete/mortar surface and cause

Fig.5 Under Water Abrasion Test

Potholes and related effects. It also provides a relative evaluation of the resistance of concrete/mortar to such action. Tests were conducted as per ASTM C 1138, and cylindrical specimens (Plain 300 mm ϕ x 100 mm) were cast and cured for 28 days. This procedure stimulates the abrasive action of waterborne particles (silt, sand, gravel, and other solids
