Original Article

# Testing the Infiltration Rate of Datar Ajab Village, Hulu Sungai District

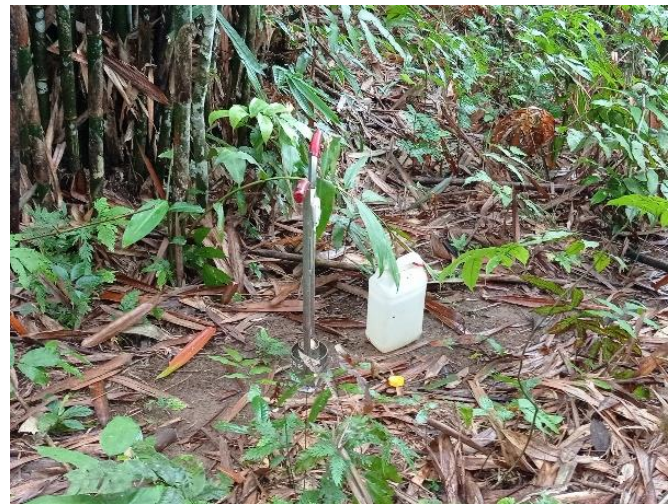
**Fig. 1 Infiltration Rate Testing in Datar Ajab Village, Hulu Sungai Tengah District**

was carried out. Direct surveys of the study region were used to collect primary data, and a double-ring infiltrometer was used to measure the infiltration rate (turf-tec infiltrometer). The Horton Method was the analytical technique employed in this investigation. The test locations are divided into three based on land cover.

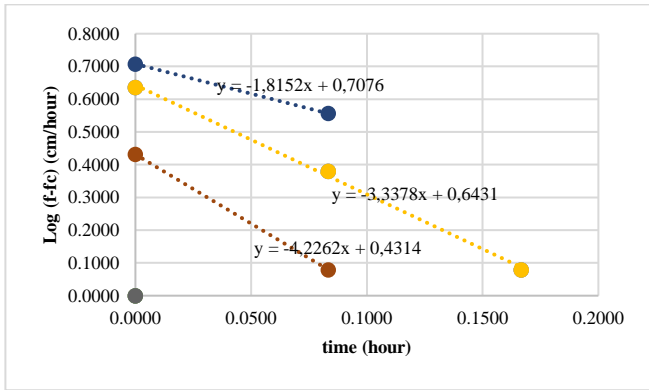
Fig. 4 Graph of Relationship Between Time (hours) and Log (f-f\_c) (cm/hour) in Test 1

Infiltration capacity can be calculated using the Horton Method formula. In hydrology, the infiltration rate is calculated using the Horton model. Horton understood that the infiltration capacity drops over time before approaching a fixed amount. The Horton Method calculation requires a constant value of k; this value can be found by using the m value on the comparison curve between t (hours) and log ( $f - f_c$ ).

$$k = -\frac{1}{0,434 \times m}, \text{ where } m = \text{gradien}$$
